COMFORT HOME REVIEW

CONFIDENTIAL INSPECTION REPORT

INSPECTION ADDRESS

INSPECTION DATE

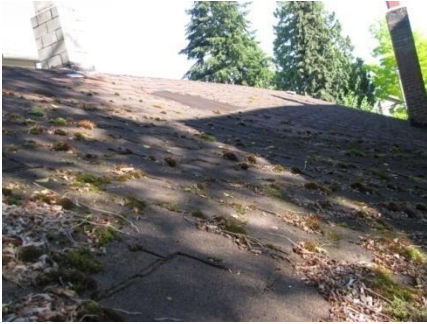
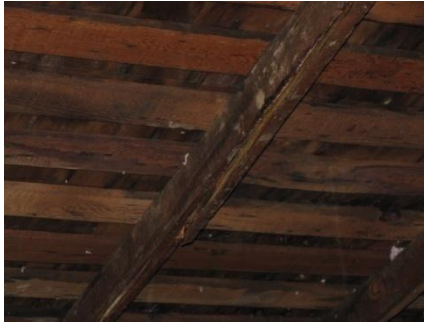
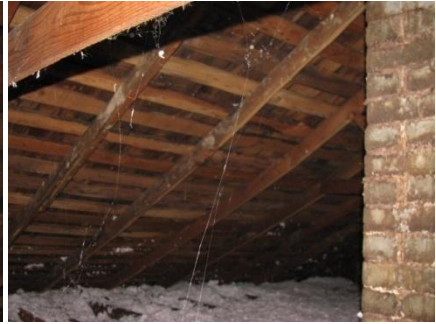
- ★ The roof structure is damaged, which dish roof is visible from roof top; cracked and bend rafters are noticed at attic. The contractor evaluation and repair is required. It looks like an impact damage, which owner enquiry

is suggested. (屋顶结构受损, 从屋顶上看有局部凹陷, 阁楼观察有木梁开裂和弯曲, 需要专业评估并维修。应该寻问屋主是否有过重物击打所致)

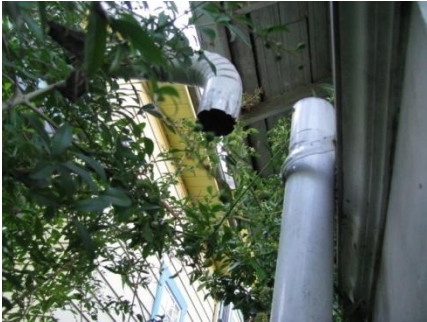
Downspout (屋顶排水)

- ★ The disconnected downspouts should be serviced.(断开的落水水管需要修缮)

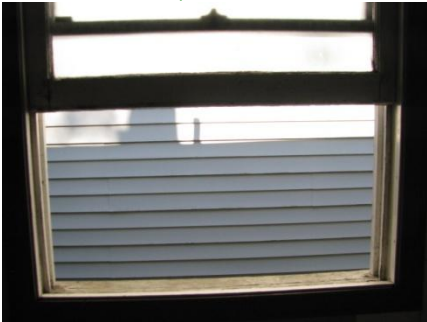
Windows (窗户)

- ★ Most windows are single glazed. Some window panes have cracks damage.(大部分窗子为单层玻璃，个别窗玻璃有裂缝)

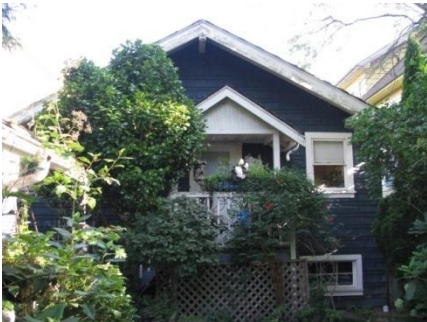
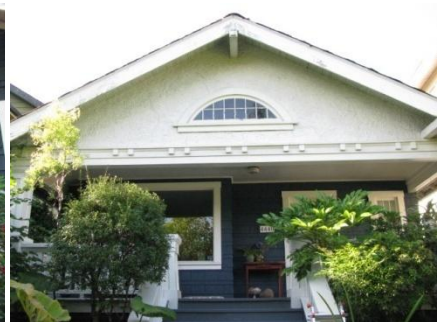
Landscaping (庭院)

- ★ Vegetation is encroaching on the structure, and should be kept a minimum of twelve inches away for the general welfare of the walls and foundation. Also the garden and trees on the property should be trimmed. (植物生长过于靠近建筑，建议至少12" 间隔，庭院植物、树木应该剪枝)

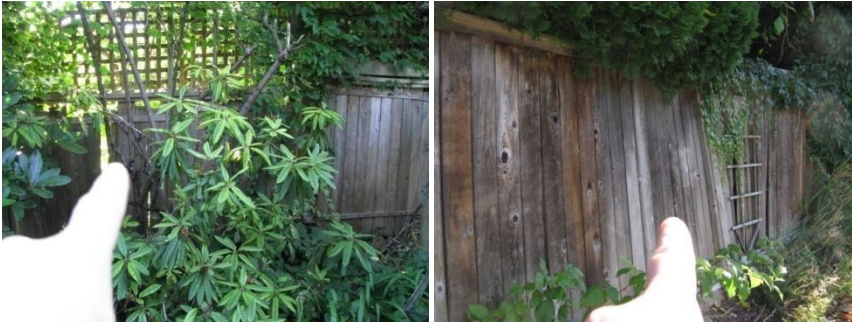
Fences & Gates (围墙及门)

- ★ Sections of the fence are leaning or damaged and should be repaired or replaced. (有破损，建议维修更换)

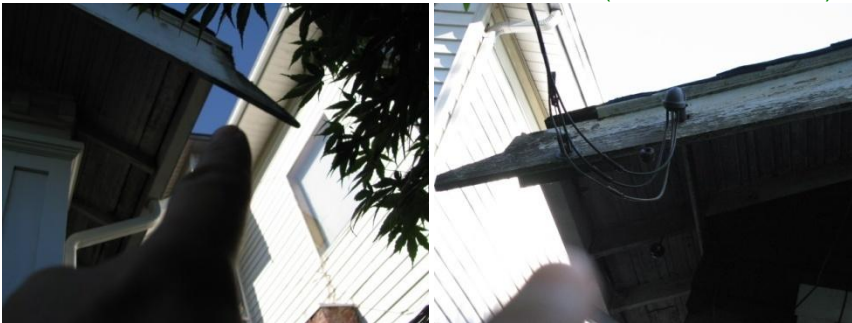
Fascia & Trim (檐板)

- ★ The fascia board and trim, should be serviced. (檐板个别需要维护)

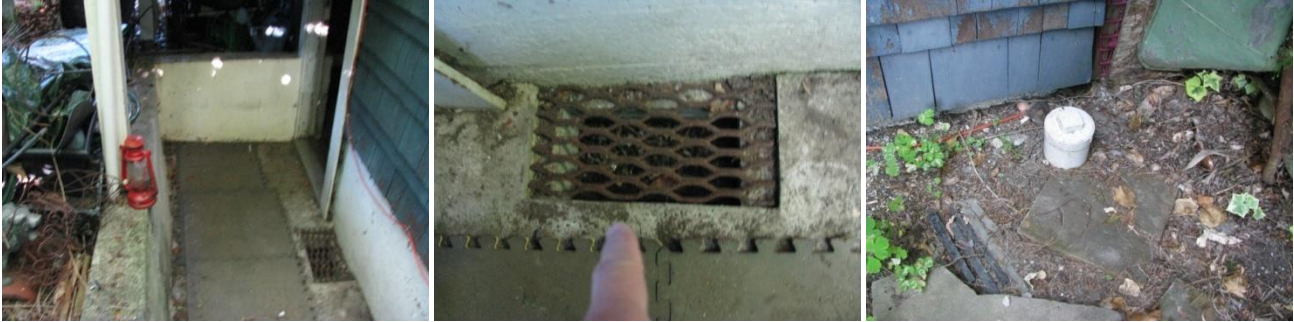
Area Drains (局部下排水)

- ★ The basement walkout drain has not been serviced for a long time. Therefore the roofer cleaning and inspection service is required including the drain tiles. (地下室门前的下水口长期没有清理, 需要排水专业人员清理、检查, 包括对墙基排水管)

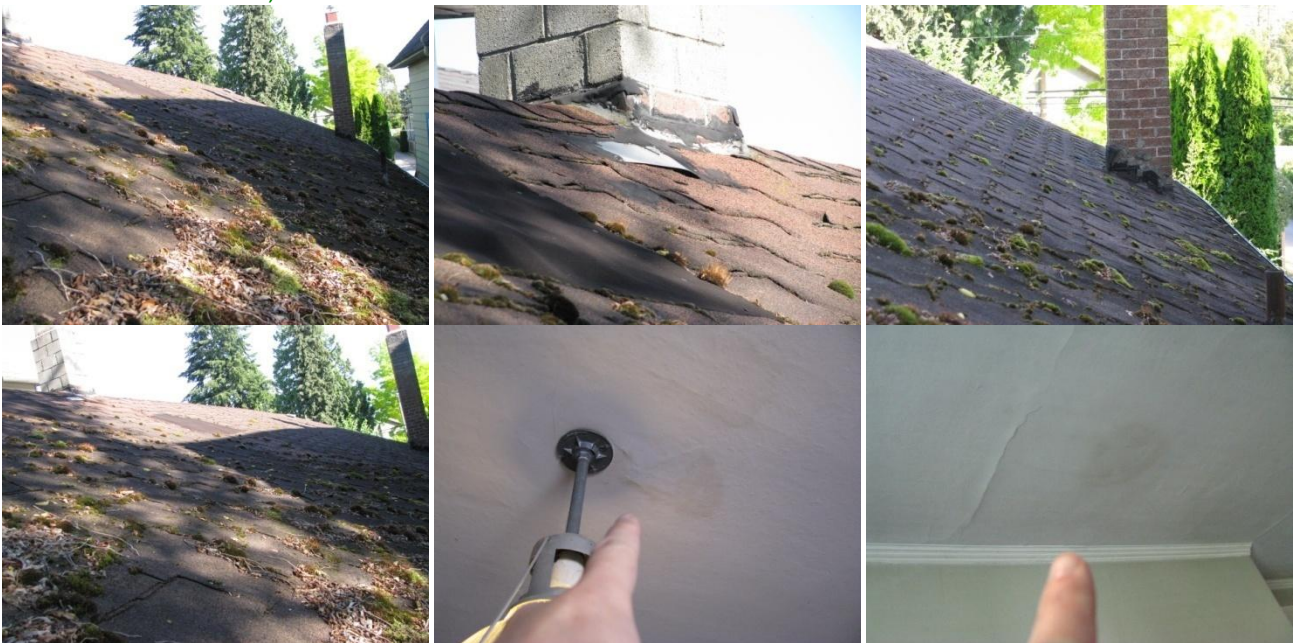
- ★ Many areas on roof have been repaired (or patched) before. It appears that there may have some leaking before (also ceiling stains). Although there is no visible active leaking during inspection, the roof replacement is required ASAP. (很多地方修补显示曾经有过漏水, 室内天花也有印记, 虽然在检验中没有漏水, 但是应该尽快更换)

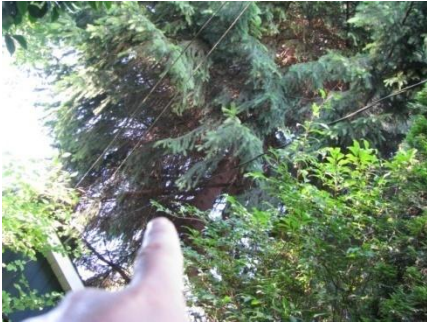
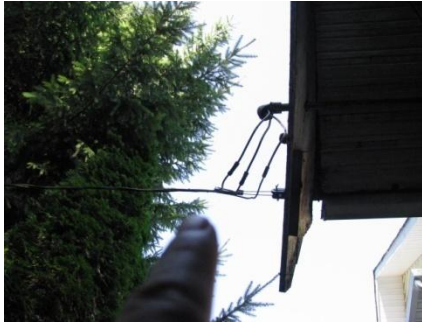
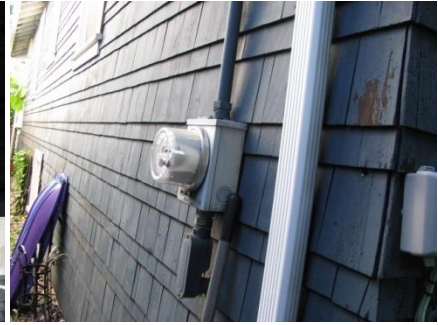
Service Entrance (进线)

- ★ The utility company's overhead conductor lines are being stressed by tree limbs that should be trimmed away. (悬挂进线受压于树枝, 剪枝)

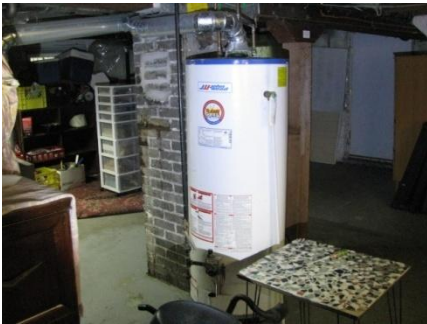
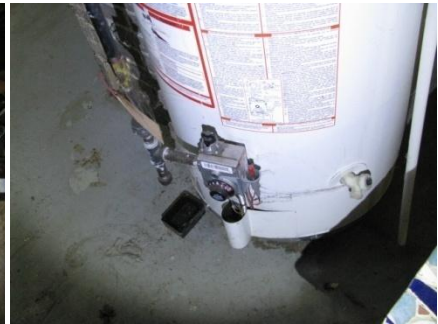
- ★ The water heater is functional but 12 yrs old is close to life expectancy. The probability of failure is high. (工作正常, 但是已经12年接近使用寿命, 损坏的可能性比较大)

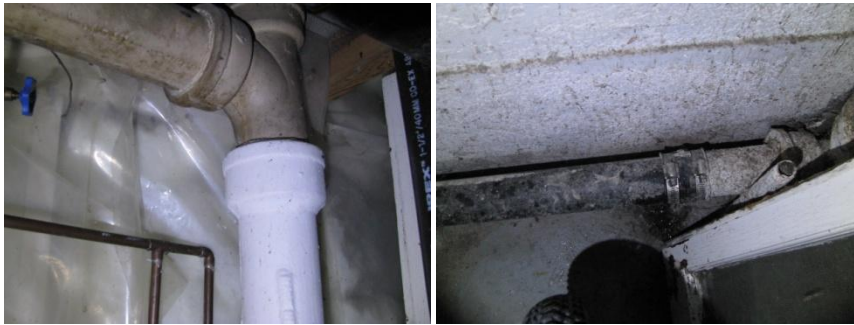
- ★ The visible portions of the drainpipes are new ABS and an older cast-iron type on main, which are old & not as dependable as modern ABS drainpipes. (可见部分为ABS和老式铸铁, 理论上铸铁基本到使用寿命)

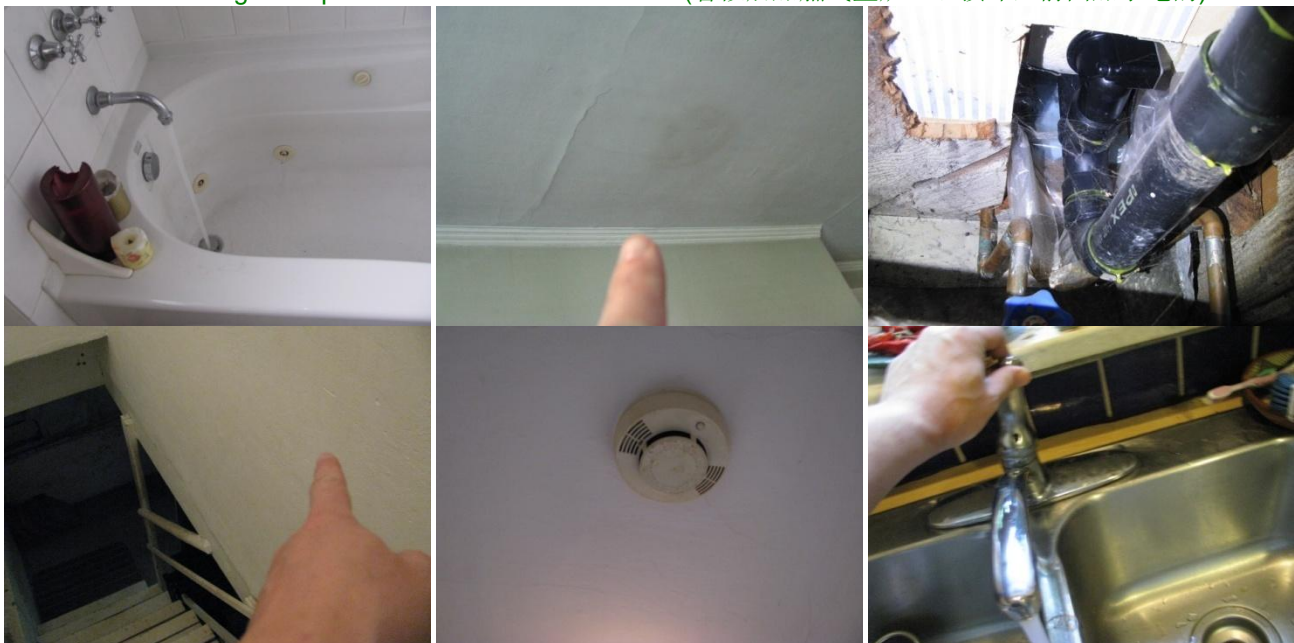
- ★ The interior appears old property like single glazed windows, old plumbing fixtures and added bath exhaust fan no outside vent in place, also tenant occupied lack of maintenance condition such as worn flooring, cracked ceiling/wall, loose doors and unfinished bedroom window casing. Some services are required right away ex. dripping bath tub drain, smoke detector update and basement stairs handrail installation for safety, also loose kitchen sink tap. The interior has the moldy smell which may result from the pets and none operable windows in living and dining. Asbestos is not avoidable in old timer. Therefore, professional cleaning, evaluation and renovation is suggested.) (室内有老旧物业特征如单层玻璃窗，老式水龙头浴缸及卫生间排风扇无室外出口，加之租客占用缺乏维护，状态欠佳如磨损的地面材料、开裂的天花墙壁、松脱的门和未完工的卧室窗口；有些需要立即修缮如浴缸下水漏，加装楼梯扶手、更新烟感，及修缮厨房水龙头。室内有霉味可能与客厅餐厅窗子打不开加之饲养宠物有关，老物业石棉材料不可避免，建议专业清洁、评估或翻新)

- ★ It looks like the gas fireplace insert has broken down. (看似后加燃气壁炉已经损坏，前面加了电的)

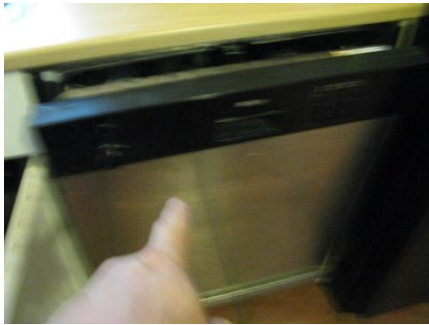
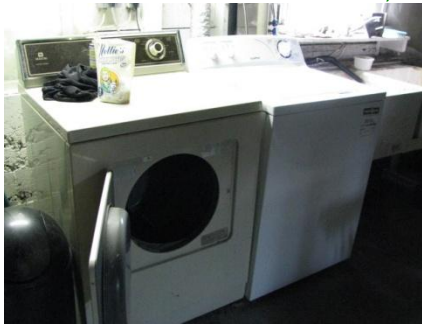
Appliances (电器)

- ★ Some appliances are functional but old and close to life expectancy such as washer, dryer and dishwasher. (有的电器虽然工作，但是老旧接近寿命，如洗衣机、干衣机和洗碗机)

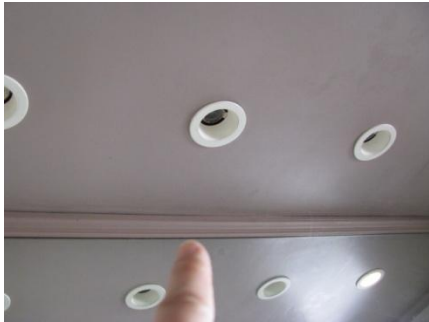
Interior lights (室内灯具)

- ★ There are a few interior lights as shown not working during the inspection but supposed to be only the bulbs out or controlled by timer/sensor. Since this is common in a home, we won't specify them in each of following area unless it is a significant failure. We also suggest clients double checking the lights before moving in if this is your concern because they can fail anytime. (室内有一些灯不工作，应该只是更换灯泡的问题或者被感应器控制，因为该情况在家居中常见，除非是特别重要的损坏我们不会在下面室内的各个部分提及。如果认为很重要，我们还建议客人在搬入前再次检查所有的灯具照明，因为其可能会在任何时间损坏)

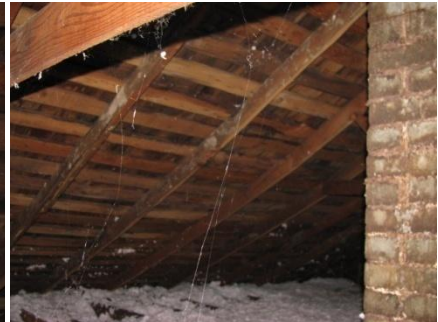
Identification of Roof Structure (屋顶结构)

- ★ The roof structure is damaged, which dish roof is visible from roof top; cracked and bend rafters are noticed at attic. The contractor evaluation and repair is required. It looks like an impact damage, which owner enquiry is suggested. (屋顶结构受损, 从屋顶上看有局部凹陷, 阁楼观察有木梁开裂和弯曲, 需要专业评估并维修。应该寻问屋主是否有过重物击打所致)

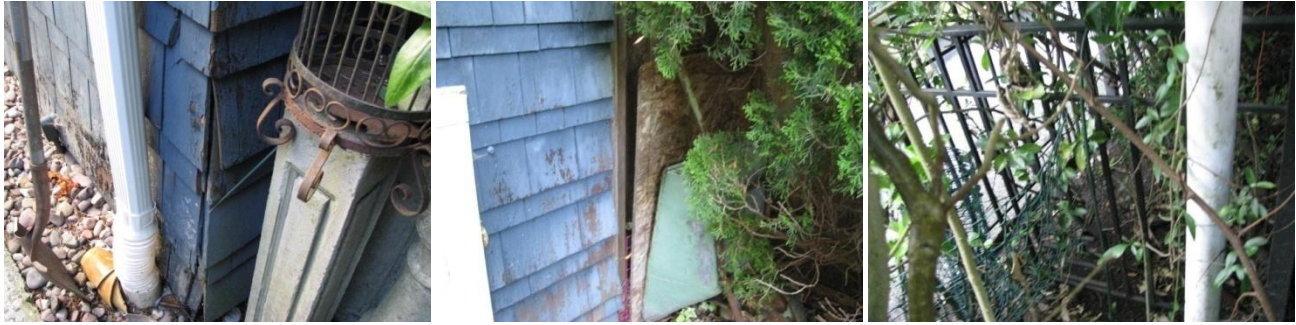
House Wall Finish Observations

- ★ The house exterior wall finish is under acceptable condition but spotty and regular maintenance services are required. The east side of house is not accessible, therefore no observation and inspection are in the area. (外墙状况正常, 个别位置需要正常维修, 物业东侧无法进入, 因此没有观察和评价)

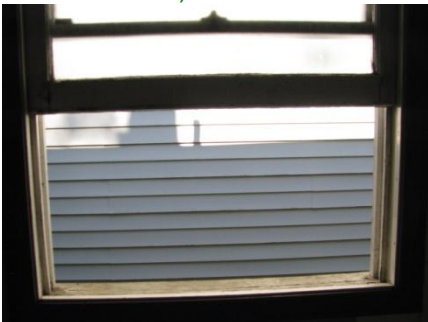
Windows (窗户)

- ★ The windows are in acceptable condition. However, in accordance with industry standards, we do not test every window in the house, and particularly if the house is furnished. We do test every unobstructed window in every bedroom to ensure that at least one facilitates an emergency exit. (窗户状况正常, 我们检查卧室里没障碍物的窗, 以确保有紧急出口)
- ★ Most windows are single glazed. Some window panes have cracks damage.(大部分窗子为单层玻璃, 个别窗玻璃有裂缝)

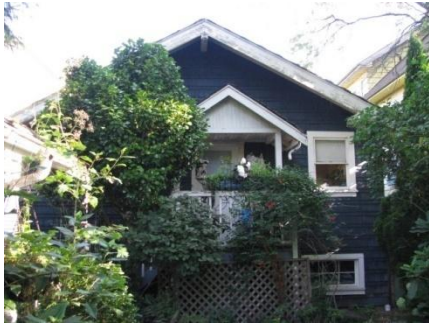
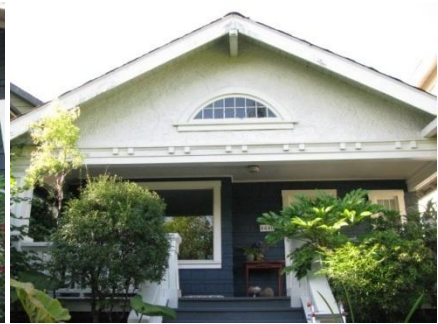
Landscaping (庭院)

- ★ Vegetation is encroaching on the structure, and should be kept a minimum of twelve inches away for the general welfare of the walls and foundation. Also the garden and trees on the property should be trimmed. (植物生长过于靠近建筑, 建议至少12" 间隔, 庭院植物、树木应该剪枝)

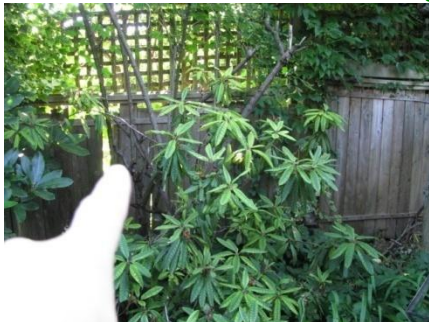
Fences & Gates (围墙及门)

- ★ Sections of the fence are leaning or damaged and should be repaired or replaced. (有破损, 建议维修更换)

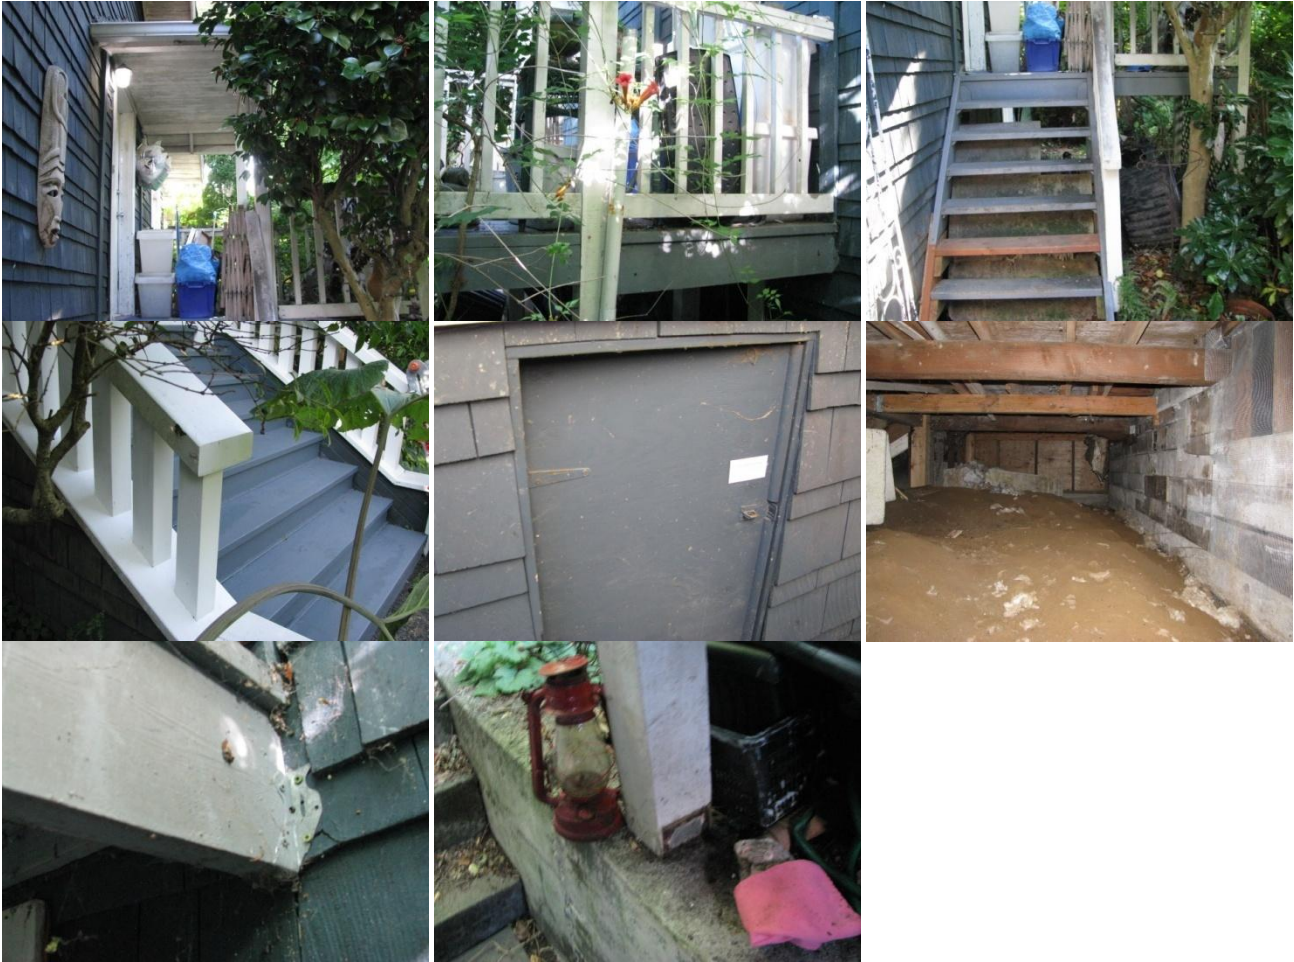
Porches (门廊)

- ★ Components of **Porches** are in acceptable condition but the back porch joist hanger is undersized, which contractor service and secure is suggested. (前后门廊状况正常, 但是后门廊的木梁墙上紧固件偏小, 建议专业维护、加固)

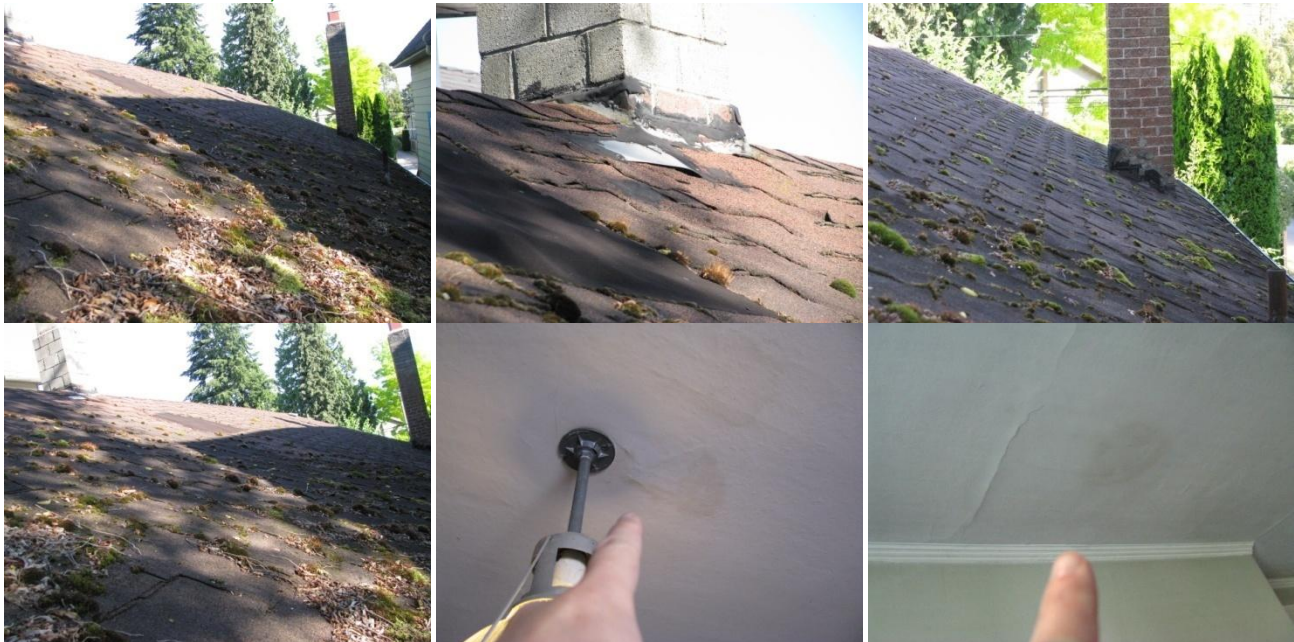
Roofing Observation (屋顶观察)

- ★ Many areas on roof have been repaired (or patched) before. It appears that there may have some leaking before (also ceiling stains). Although there is no visible active leaking during inspection, the roof replacement is required ASAP. (很多地方修补显示曾经有过漏水, 室内天花也有印记, 虽然在检验中没有漏水, 但是应该尽快更换)

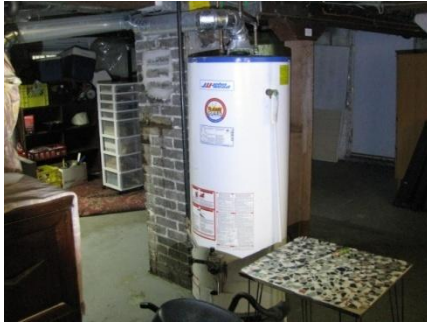
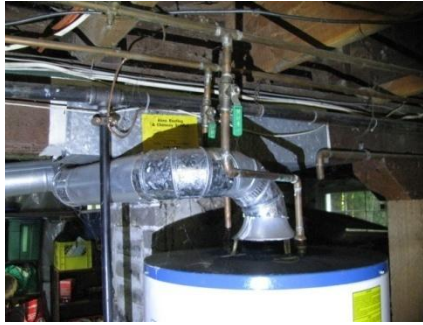
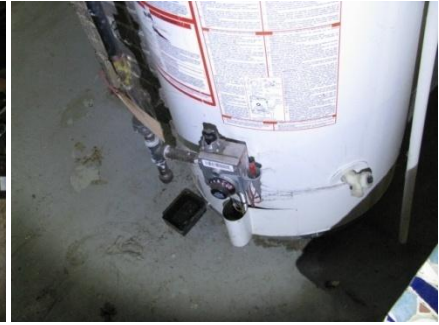
- ★ The water heater is functional but 12 yrs old is close to life expectancy. The probability of failure is high. (工作正常, 但是已经12年接近使用寿命, 损坏的可能性比较大)

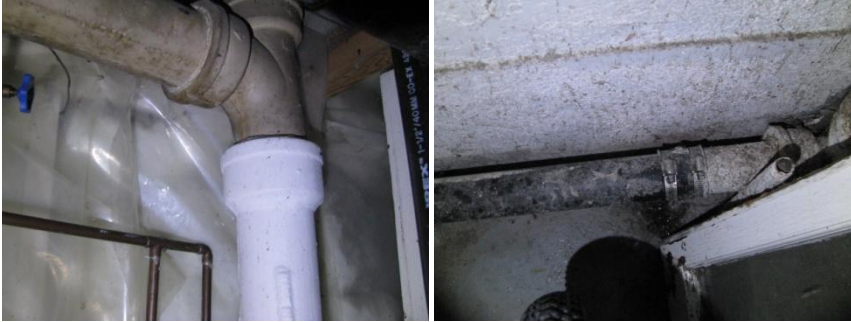
Type of Material (材料)

- ★ The visible portions of the drainpipes are new ABS and an older cast-iron type on main, which are old & not as dependable as modern ABS drainpipes. (可见部分为ABS和老式铸铁, 理论上铸铁基本到使用寿命)

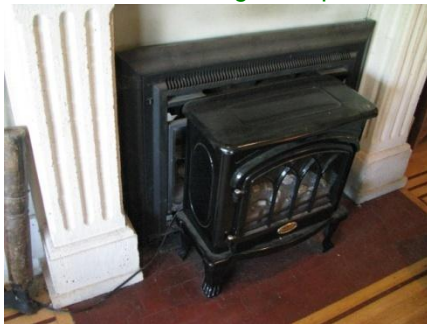
Fireplace (壁炉)

★ It looks like the gas fireplace insert has broken down. (看似后加燃气壁炉已经损坏，前面加了电的)

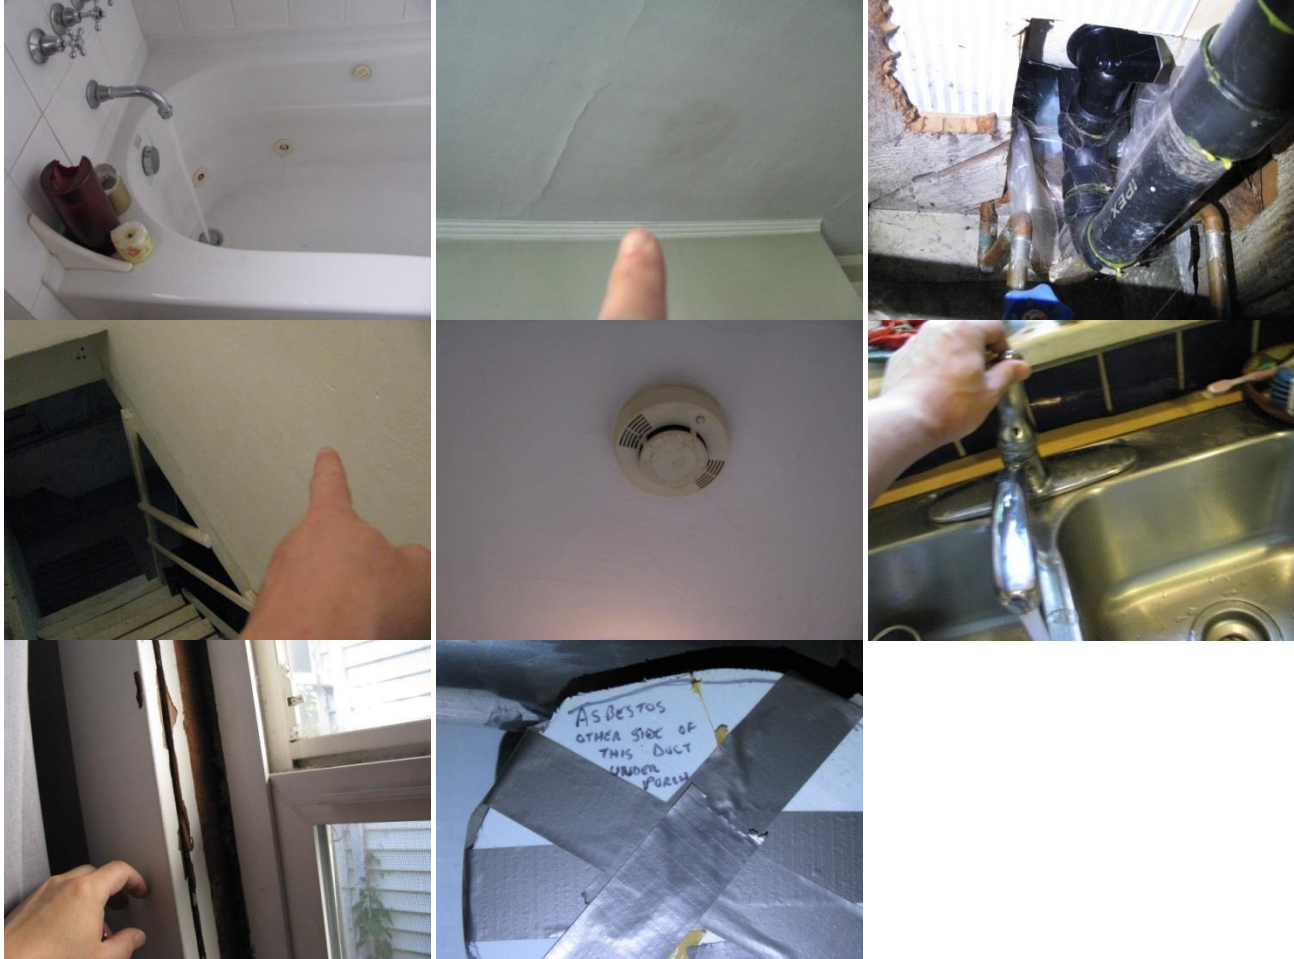
Over all interior condition (室内状况)

- * The interior appears old property like single glazed windows, old plumbing fixtures and added bath exhaust fan no outside vent in place, also tenant occupied lack of maintenance condition such as worn flooring, cracked ceiling/wall, loose doors and unfinished bedroom window casing. Some services are required right away ex. dripping bath tub drain, smoke detector update and basement stairs handrail installation for safety, also loose kitchen sink tap. The interior has the moldy smell which may result from the pets and none operable windows in living and dining. Asbestos is not avoidable in old timer. Therefore, professional cleaning, evaluation and renovation is suggested.) (室内有老旧物业特征如单层玻璃窗, 老式水龙头浴缸及卫生间排风扇无室外出口, 加之租客占用缺乏维护, 状态欠佳如磨损的地面材料、开裂的天花墙壁、松脱的门和未完工的卧室窗口; 有些需要立即修缮如浴缸下水漏, 加装楼梯扶手、更新烟感, 及修缮厨房水龙头。室内有霉味可能与客厅餐厅窗子打不开加之饲养宠物有关, 老物业石棉材料不可避免, 建议专业清洁、评估或翻新)

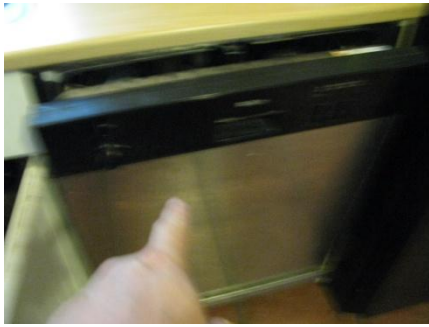
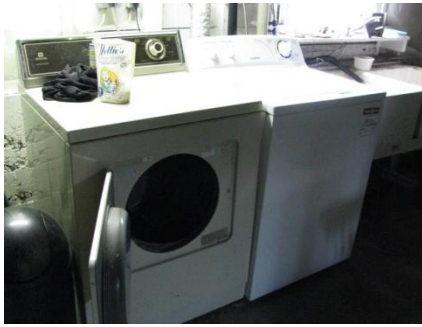
Appliances (电器)

- * Some appliances are functional but old and close to life expectancy such as washer, dryer and dishwasher.(有的电器虽然工作, 但是老旧接近寿命, 如洗衣机、干衣机和洗碗机)

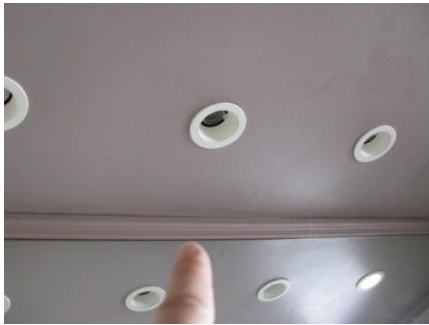
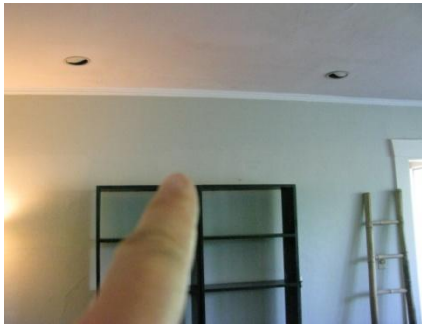
Interior lights (室内灯具)

- ★ There are a few interior lights as shown not working during the inspection but supposed to be only the bulbs out or controlled by timer/sensor. Since this is common in a home, we won't specify them in each of following area unless it is a significant failure. We also suggest clients double checking the lights before moving in if this is your concern because they can fail anytime. (室内有一些灯不工作, 应该只是更换灯泡的问题或者被感应器控制, 因为该情况在家居中常见, 除非是特别重要的损坏我们不会在下面室内的各个部分提及。如果认为很重要, 我们还建议客人在搬入前再次检查所有的灯具照明, 因为其可能会在任何时间损坏)

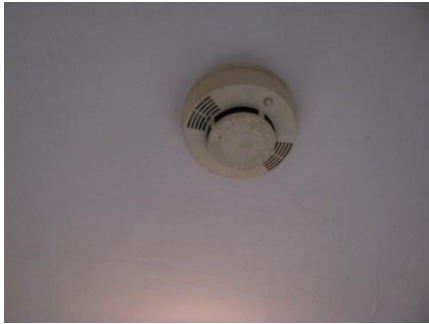
Smoke Detector (烟雾报警器)

- ★ The smoke detector update is suggested for safety. (建议更新烟感，以为安全)
