COMFORT HOME REVIEW

CONFIDENTIAL INSPECTION REPORT

XXXXXXXX, Richmond

Nov 28, 2015

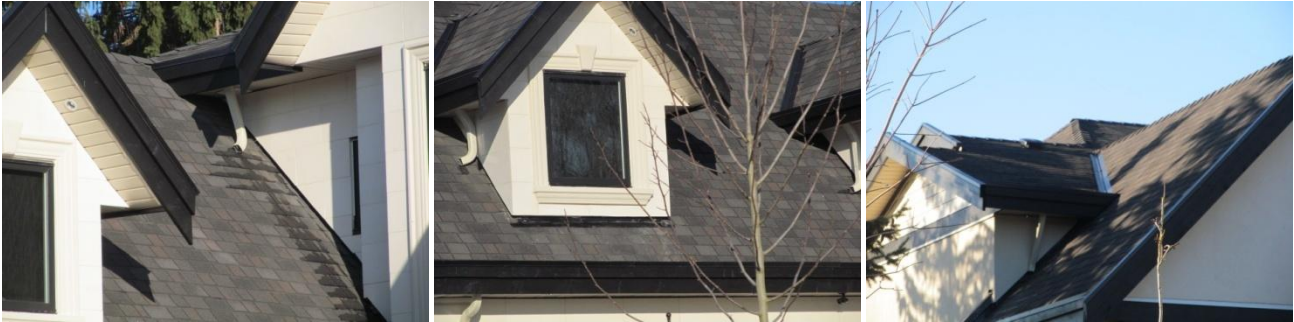
- ★ The top level downspout is suggested to extend to lower gutter to avoid roof shingle pre-mature damage. (建议将上层下水管延伸至下层檐沟)

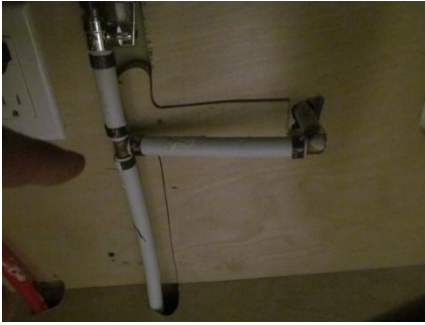
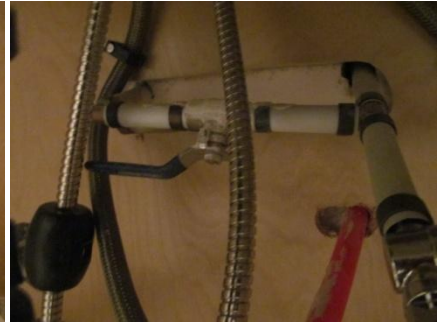
Garden Shut-off Location (室外水管的截止阀)

- ★ The garden hose bib shut off valves are located under laundry sinks but please ask seller to confirm. One should be installed for back yard tap under wok kitchen sink (室外水管截止阀在洗衣间水盆下, 但是请寻问屋主来确认, 建议中厨水盆下加装关停后院的水阀)

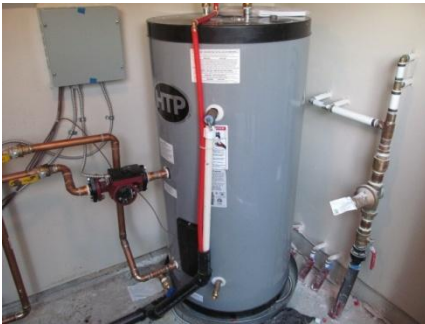
Seismic Straps (防震加固)

- ★ The water heater is not seismically secured, which is recommended. (建议防震加固)

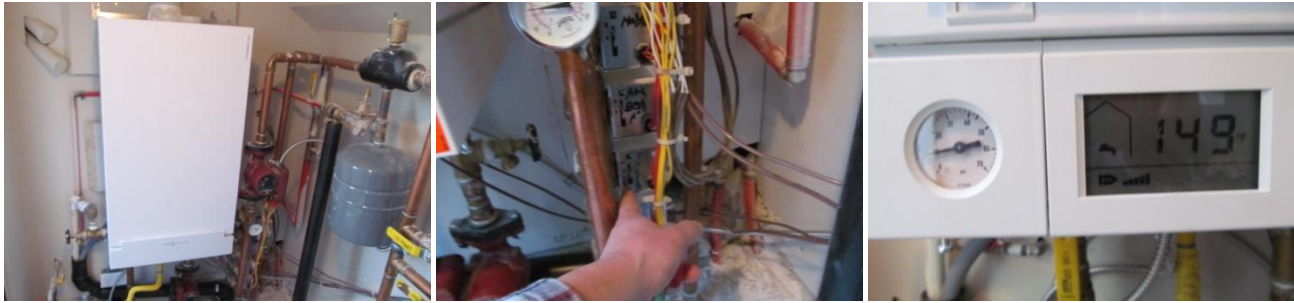
Boilers (锅炉)

- ★ The new boiler is a hot water type that should be inspected and serviced by the contractor for the circulation problem and all zone valves shut off even the thermostats on high, which also caused short of hot water at inspection. (新水锅炉需要建商检查、维护, 检查时即便要求升温但全部区域阀关停, 也造成无热水提供)

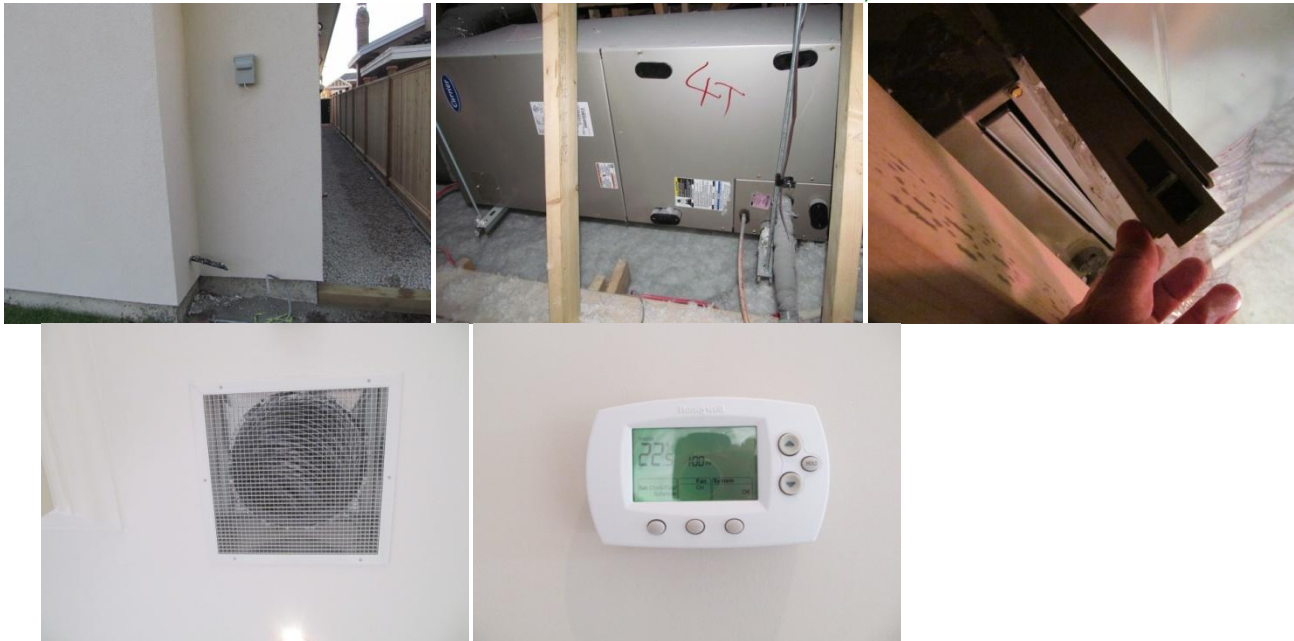
- ★ No compressor installed; The evaporator is in attic and filter compartment should be serviced to maintain easily. It is suggested relocating the filter to air return for easy replacement. (空调压缩机没安装, 蒸发器在阁楼, 滤清器安装需要维修以便于更换, 建议将滤网安装于回风口以便于维护)

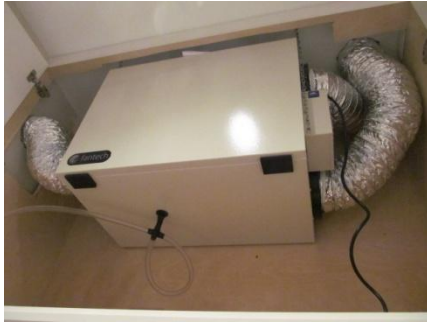
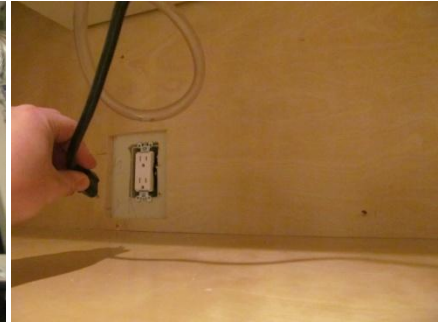
- ★ The HRV is installed at laundry and no filters in place, the power cord can't reach the outlet, which should be serviced. (换风设备在洗衣房, 没有安装滤网, 电源线距离插座过远, 维修)

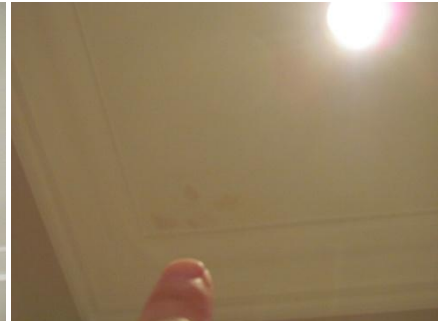
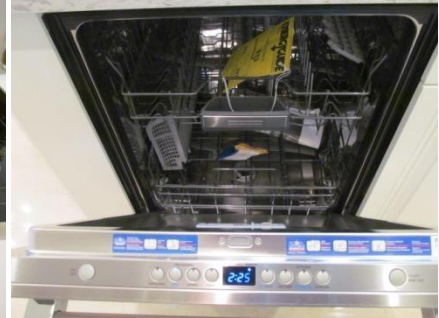
- ★ There are lots of places need either touch-up or minor service. We put the stickers over there as you can see, also the hall way ceiling close to laundry. Some appliances can't be tested for the lack of power or not in running condition, which should be inspected by seller e.g. washer, electrical cook top, oven, and dishwasher, etc. (多处需要修补, 绿色胶带指示, 包括靠近洗衣房的天花; 由于没接电或不具备运行条件, 有电器没试若电炉头、洗衣机、烤箱和洗碗机等, 需要卖家确认工作正常)

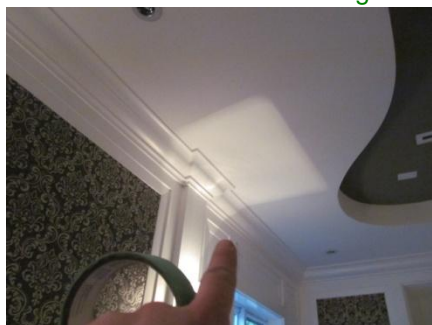
- ★ The broken media room lights should be fixed. (放映室灯维修)

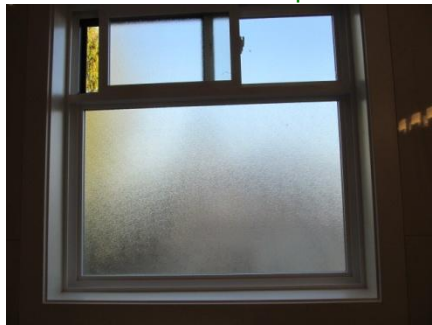
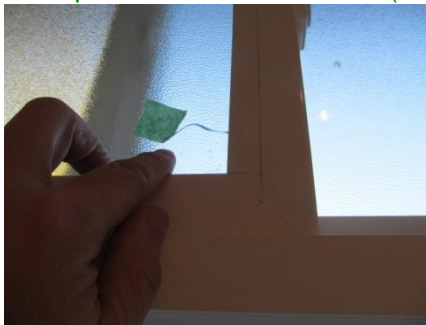
- ★ The scratch window pane should be replaced at master en-suite. (主卧浴室内划伤的玻璃更换)

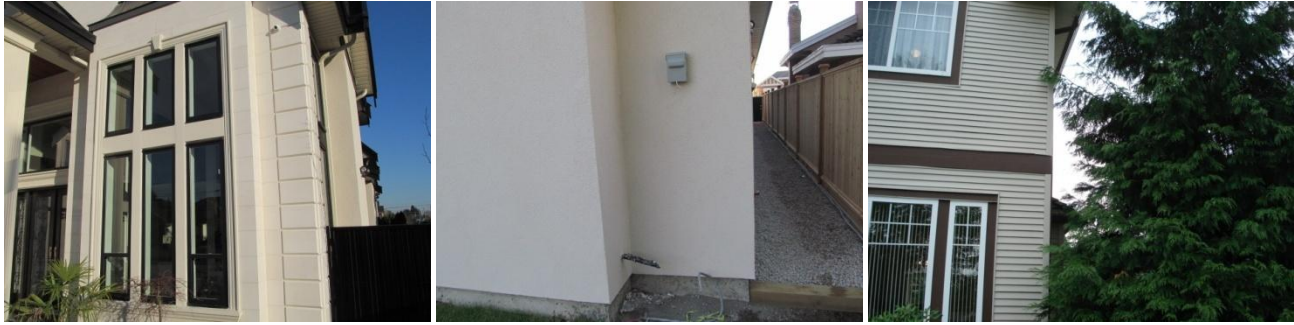
- ★ The house walls are finished with a combination of stucco and stone brick siding. (外墙为灰泥/石材)

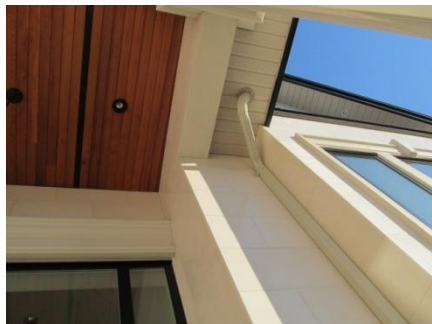
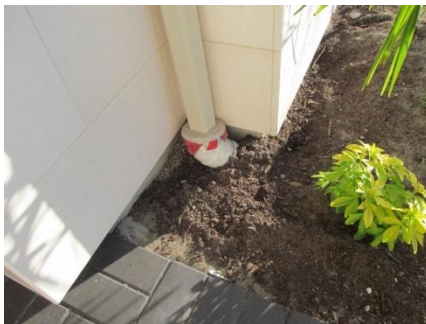
Downspout (屋顶排水)

- ★ The downspouts are made by plastic. (排水管为塑料)
- ★ The downspouts are discharged below ground level. (地下排水)

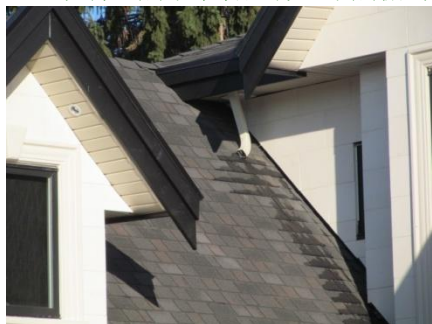
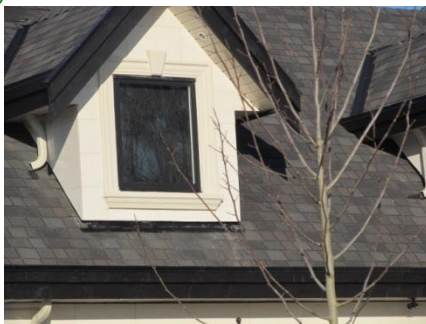
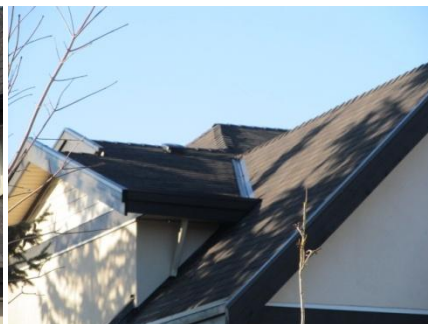
- ★ The top level downspout is suggested to extend to lower gutter to avoid roof shingle pre-mature damage. (建议将上层下水管延伸至下层檐沟)

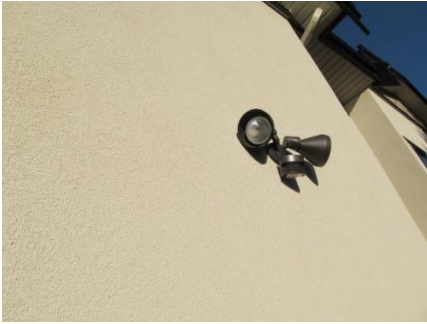
- ★ A few exterior light fixtures are not working, and should be serviced. They may be controlled by timer or sensors. Please ask seller for more information. (个别灯不工作, 需要维修; 或者是传感器控制, 需向屋主了解)

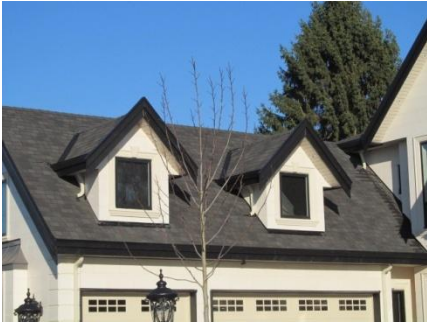
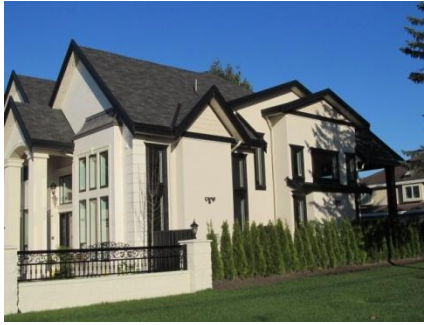
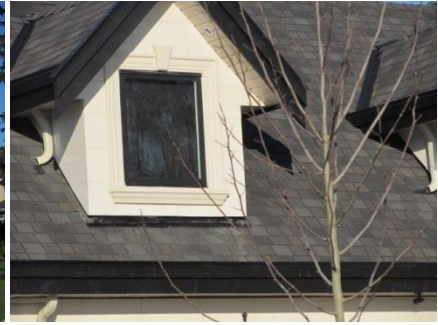
- * The roof is under acceptable condition, but this is not a guarantee against leaks. For a guarantee, you would need to have a roofing company perform a water-test and issue a roof certification. (状况正常, 但是只有专业屋顶公司进行水试才能确保不漏)
- * Some pcs of shingle and gutter/roof flashing should be serviced to apply orderly. (个别瓦片、檐沟和屋顶交接防水需要整修)

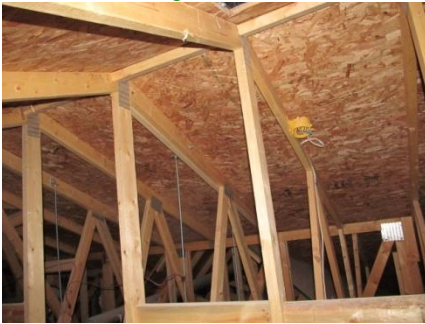
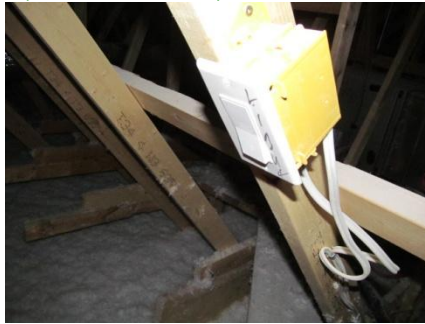
- ★ The attic light should be installed. (阁楼灯需要安装)

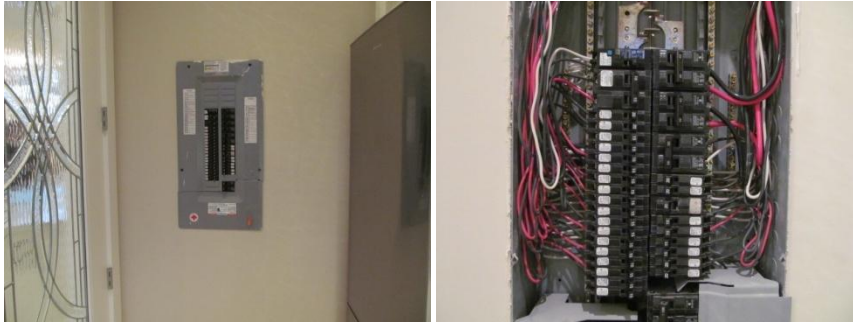
- ★ The 100A sub-panel is located in wok kitchen. (100A附电盘在中厨)

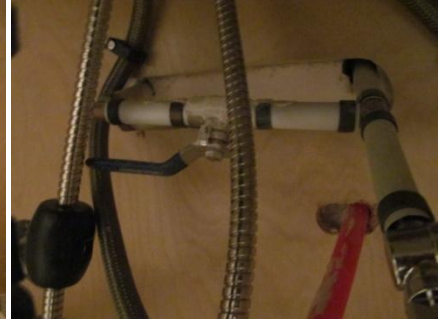
- ★ The interior hose bib shut off valves should be turned off & left the exterior hose taps open before winter to avoid frost damage. It is also important to remove the hose from the tap adaptors. Some houses do not have the interior shut-off, which the insulation cover is recommended on the exterior taps during the winter. (冬季前应该将室外水管的室内截止阀关闭, 将室外的打开, 并且将软管从水龙头移除来避免冻裂; 对于没有室外室外水龙头室内截止阀的物业, 建议冬季室外水龙头上加保温)
- ★ The garden hose bib shut off valves are located under laundry sinks but please ask seller to confirm. One should be installed for back yard tap under wok kitchen sink (室外水管截止阀在洗衣间水盆下, 但是请寻问屋主来确认, 建议中厨水盆下加装关停后院的水阀)

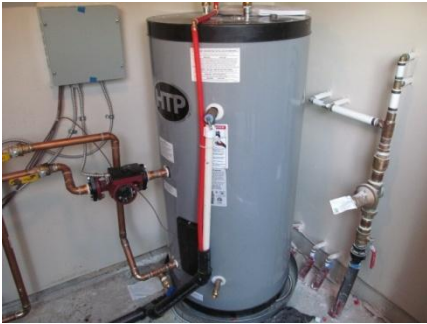
Seismic Straps (防震加固)

- ★ The water heater is not seismically secured, which is recommended. (建议防震加固)

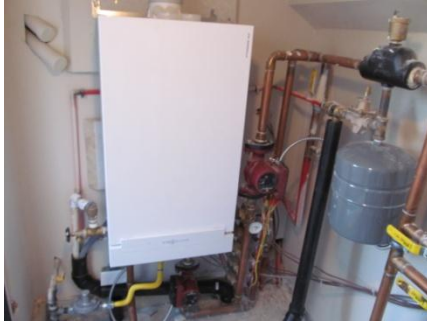
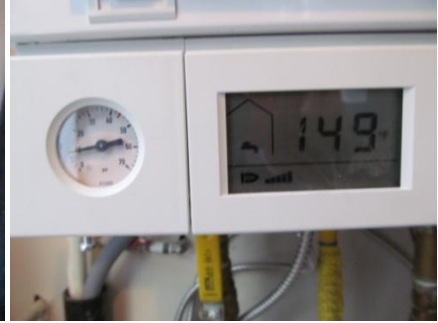
- ★ The new boiler is a hot water type that should be inspected and serviced by the contractor for the circulation problem and all zone valves shut off even the thermostats on high, which also caused short of hot water at inspection. (新水锅炉需要建商检查、维护, 检查时即便要求升温但全部区域阀关停, 也造成无热水提供)

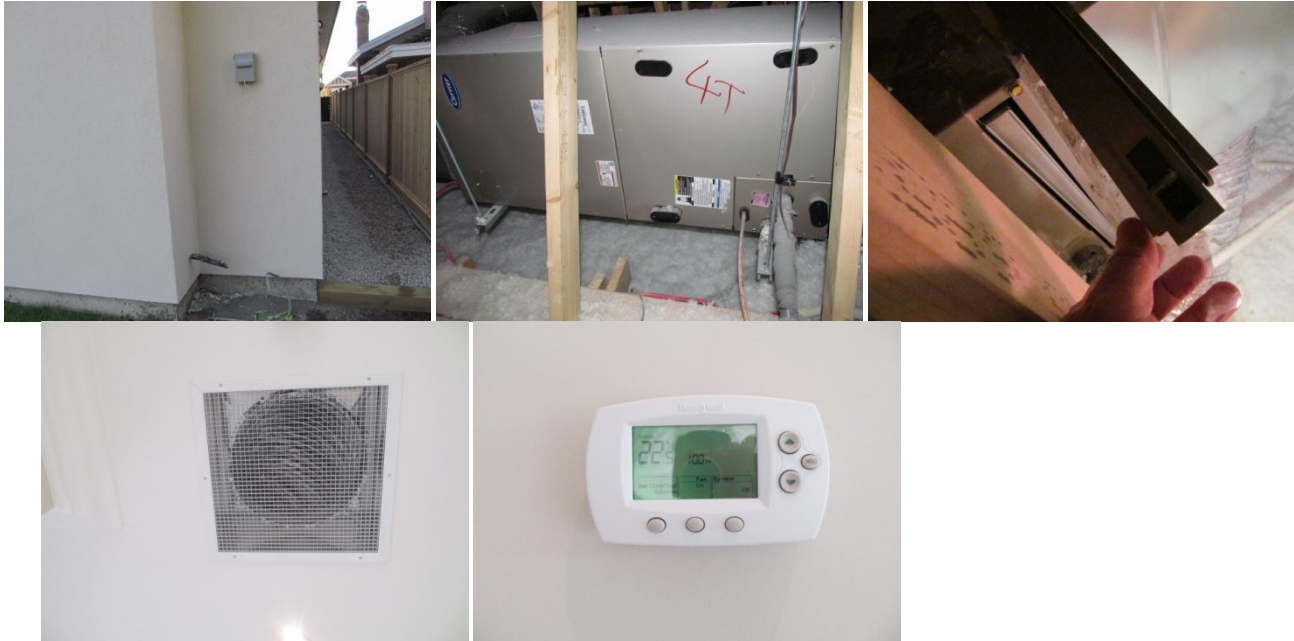
- ★ No compressor installed; The evaporator is in attic and filter compartment should be serviced to maintain easily. It is suggested relocating the filter to air return for easy replacement. (空调压缩机没安装, 蒸发器在阁楼, 滤清器安装需要维修以便于更换, 建议将滤网安装于回风口以便于维护)

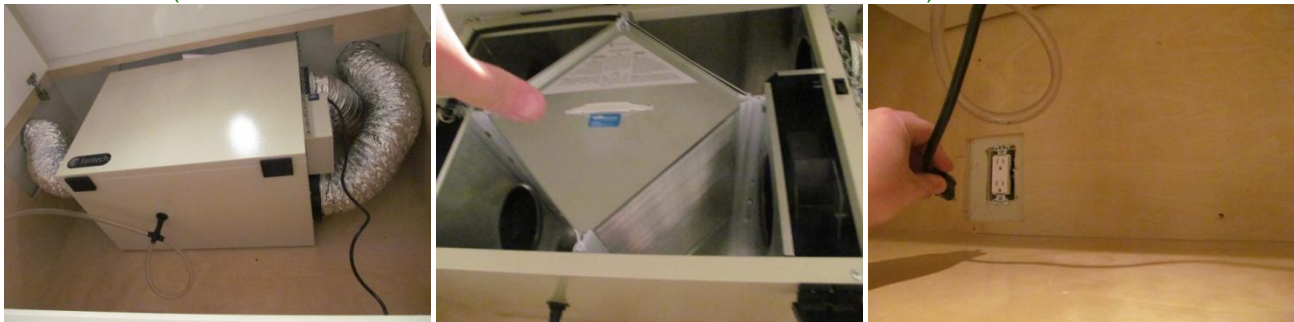
- ★ The HRV is installed at laundry and no filters in place, the power cord can't reach the outlet, which should be serviced. (换风设备在洗衣房, 没有安装滤网, 电源线距离插座过远, 维修)

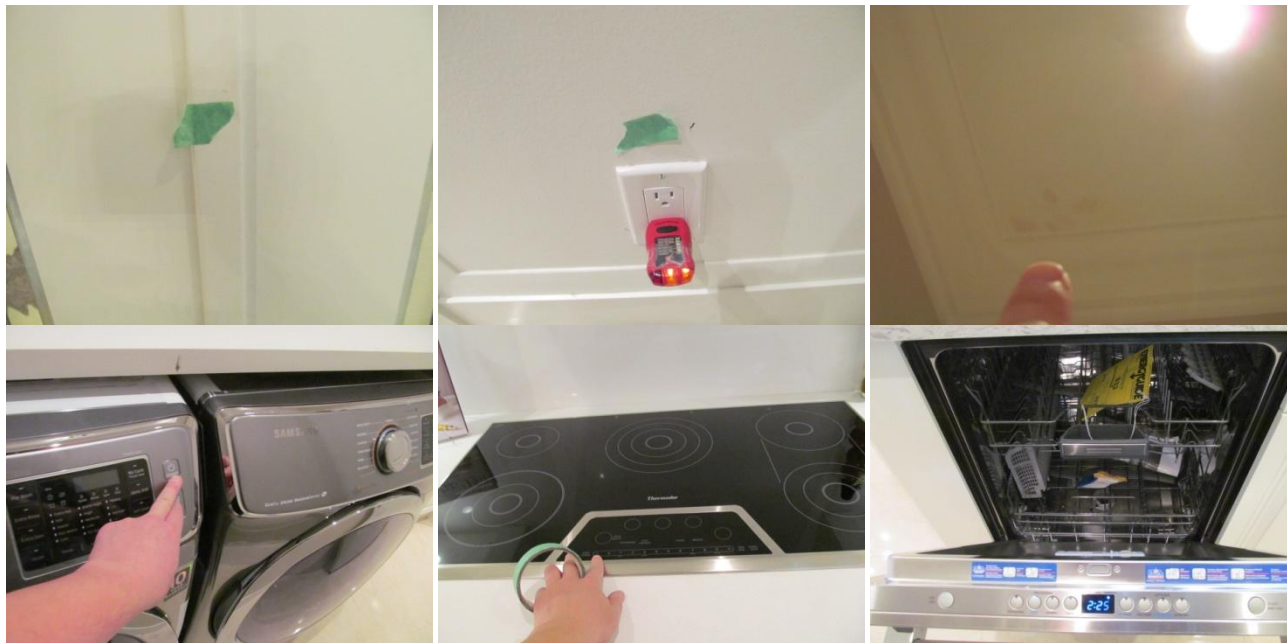
- ★ There are lots of places need either touch-up or minor service. We put the stickers over there as you can see, also the hall way ceiling close to laundry. Some appliances can't be tested for the lack of power or not in running condition, which should be inspected by seller e.g. washer, electrical cook top, oven, and dishwasher, etc. (多处需要修补, 绿色胶带指示, 包括靠近洗衣房的天花; 由于没接电或不具备运行条件, 有电器没试若电炉头、洗衣机、烤箱和洗碗机等, 需要卖家确认工作正常)

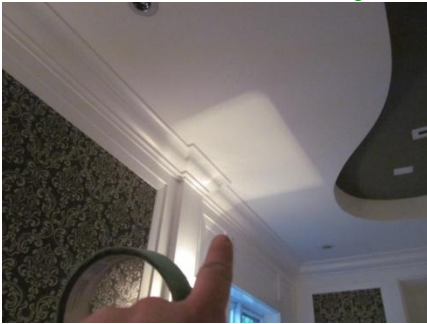
- ★ The broken media room lights should be fixed. (放映室灯维修)

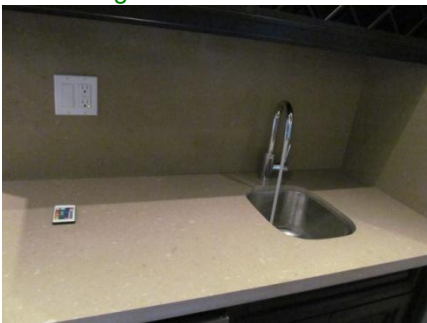
- ★ The lights on media room bar counter should be serviced to work properly(放映室吧台上的灯维修)

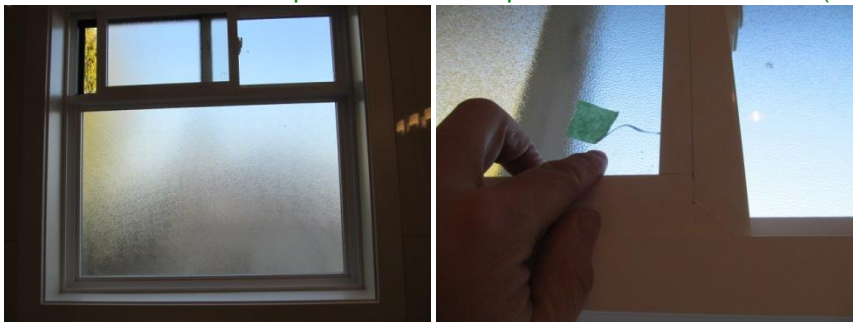
- ★ The scratch window pane should be replaced at master en-suite. (主卧浴室内划伤的玻璃更换)
