COMFORT HOME REVIEW

CONFIDENTIAL INSPECTION REPORT

SUMMARY REPORT

Inspection Address:	#####, Surrey
Inspection Date:	#####
Weather:	Sunny 15-20 C
Inspector:	Liu, Hongwei (Henry)
Buyer's Agent:	#####
Seller's Agent:	
Structure Type:	Wood Frame
Foundation Type:	Crawl space
Furnished:	Yes
Number of Stories:	2
Structure Style:	Single house
Structure Orientation:	North
Estimated Year Built:	1998
Unofficial Sq.Ft:	2,700 SF
People on Site At Time of Inspection:	Buyer, Agent, Seller

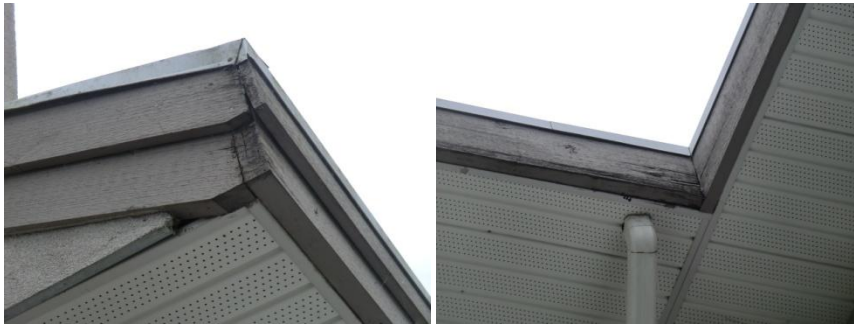
Fascia & Trim

- ★ The fascia & trim need typical painting service.

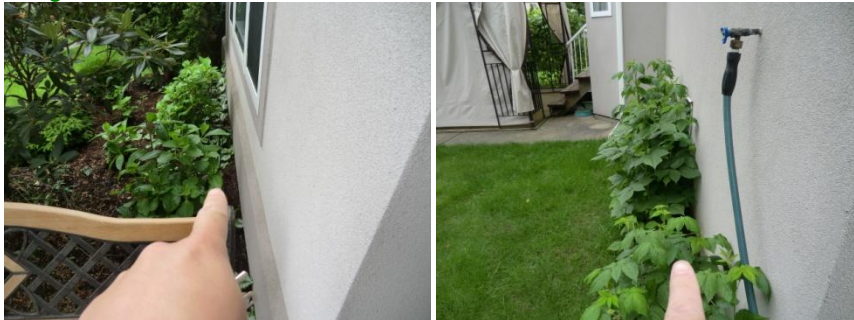
Landscaping

- ★ Vegetation is encroaching on the structure, and should be kept a minimum of twelve inches away for the general welfare of the walls and foundation.

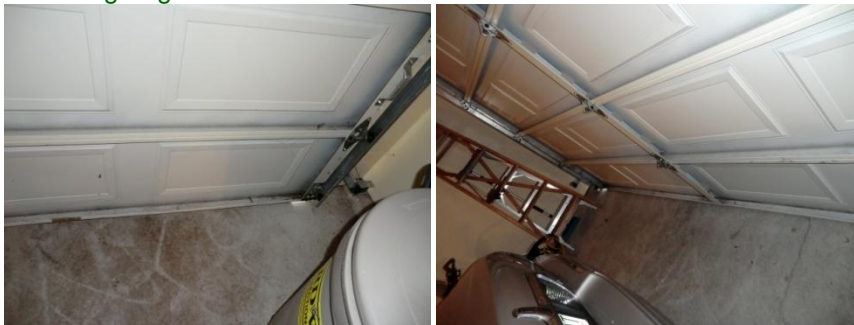
Garage Door & Hardware

- ★ The garage doors and their hardware are functional but better to extend bottom seal to keep rodents out.

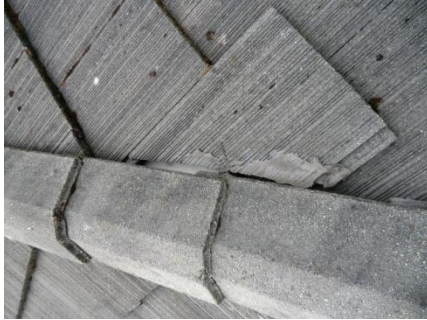
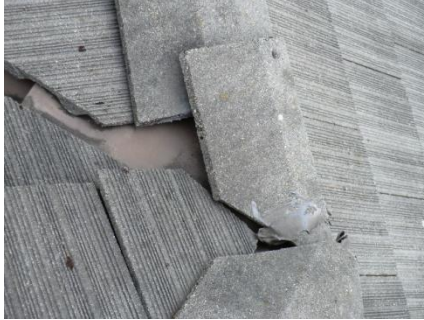
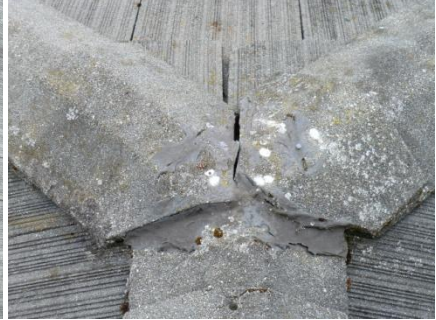
Roofing Observation

- ★ Many areas on roof need service. Although there is no visible active leaking during inspection, further evaluation is required or enquiry to the seller for more information.

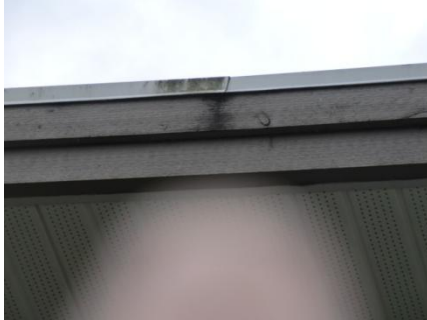
Gutters & Drainage

- ★ The gutters have the sign of dripping and need to be serviced, such as re-securing them, sealing seams, etc.

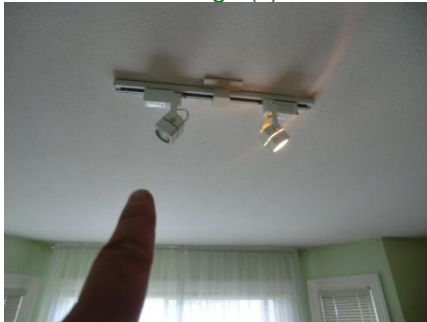
Lights

- ★ There is/are light(s) which does not respond and should be serviced.

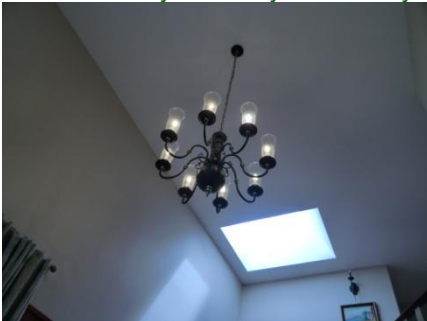
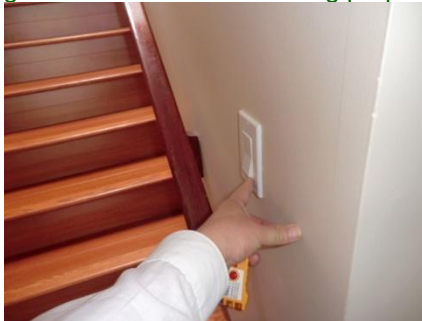
**Hall way
Lights**

★ The 2-way or 3-way main entry light switches are not working properly, which needs service

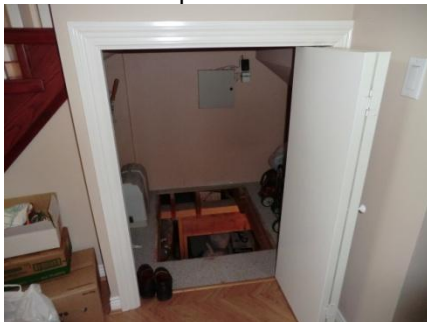
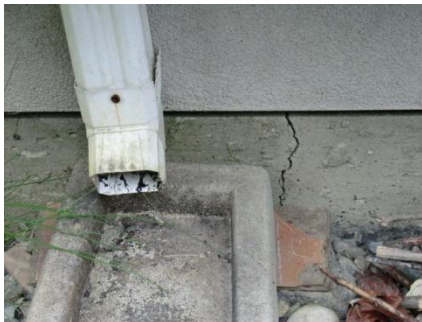
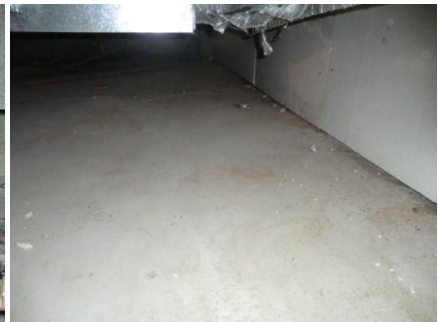
Crawlspace Observations

- * The crawlspace is accessible and in acceptable condition. There is shrinkage crack on foundation wall, which is often seen. The crawl is dry at the inspection. But make sure the proper grade slope and drain tile are essential to prevent water intrusion.
- * The access is in hall way closet.
- * The crawlspace is heated & insulation mounted on the wall.

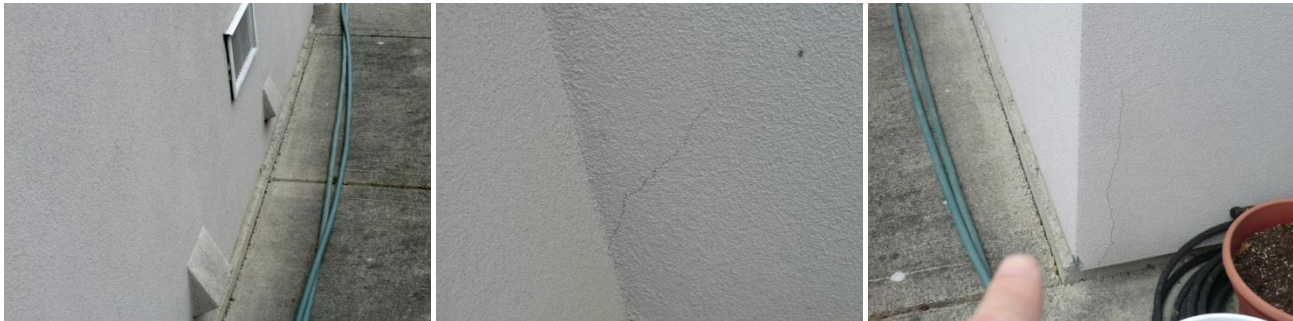
House Wall Finish Type

- ★ The house walls are finished with stucco.

- ★ The stucco finish was examined and small cracks were noted at various locations. It is believed that no on-going movement is occurring at the present time and that the cracking appears repairable. It should be noted that settlement cracking is a common occurrence in stucco wall surfaces and the cracking observed is believed to be typical of that found in the average home.

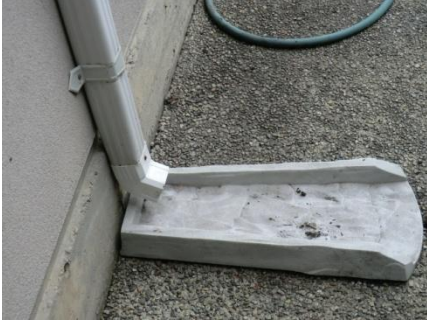
Downspout

- ★ The downspouts are made by plastic.
- ★ The downspouts are discharged on ground level.

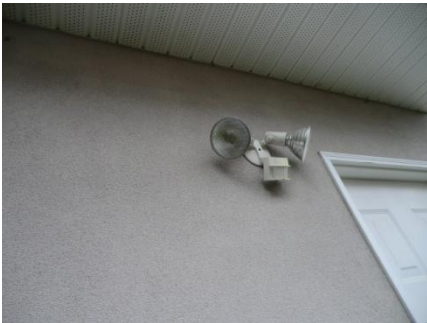
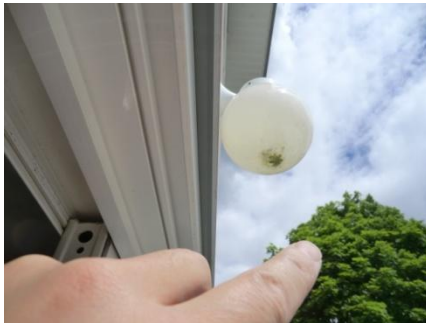
Lights

- ★ A few exterior light fixtures are not working, and should be serviced. They may be controlled by timer or sensors. Please ask seller for more information.

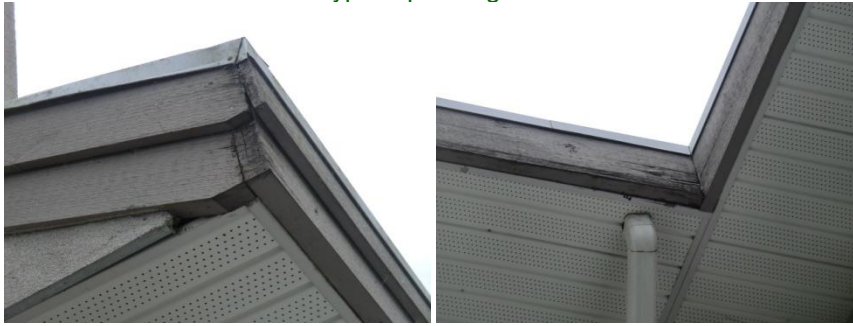
- ★ The fascia & trim need typical painting service.

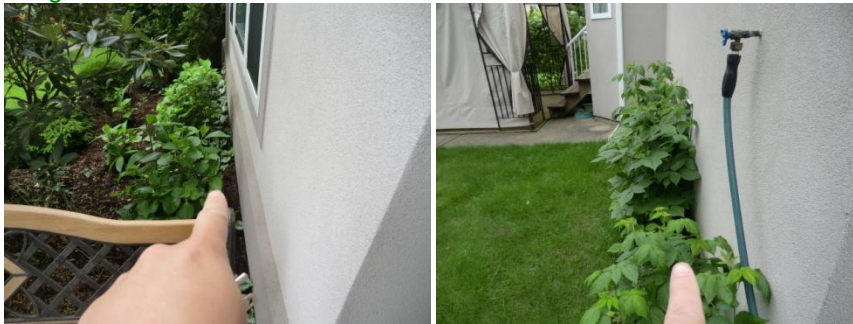
Landscaping

- ★ The Lot grade is under acceptable condition.
- ★ Vegetation is encroaching on the structure, and should be kept a minimum of twelve inches away for the general welfare of the walls and foundation.

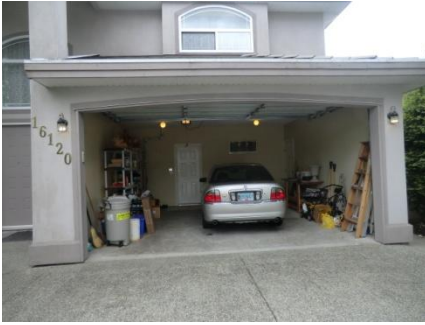
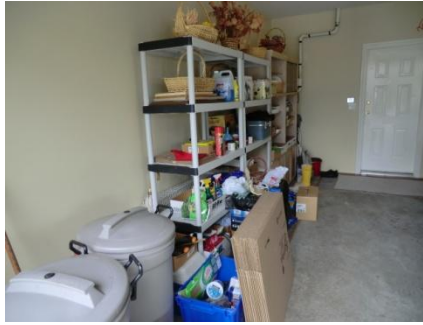
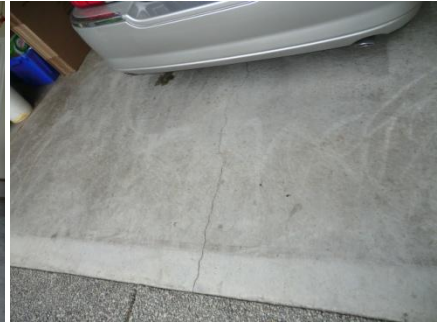
- ★ The concrete floor is under acceptable condition. Small cracks are common and result as a consequence of the curing process, seismic activity, common settling, or the presence expansive soils, but are not structurally threatening. Also, you may notice some salt crystal formations that are activated by moisture penetrating the slab.
- ★ There are storage/car in garage, and in accordance with industry standards we only inspect those surfaces that are exposed and readily accessible. We do not move storage items/furniture, lift carpets, nor remove or rearrange items within storage cabinets.

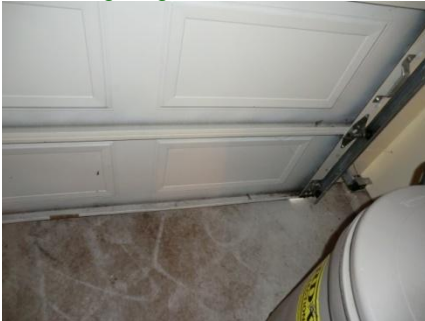
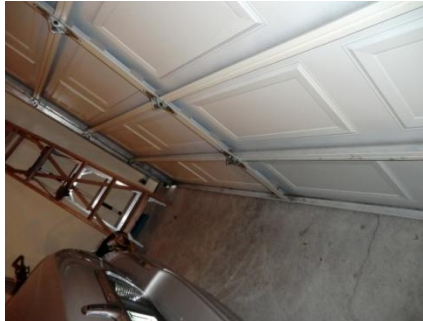
Garage Door & Hardware

- ★ The garage doors and their hardware are functional but better to extend bottom seal to keep rodents out.

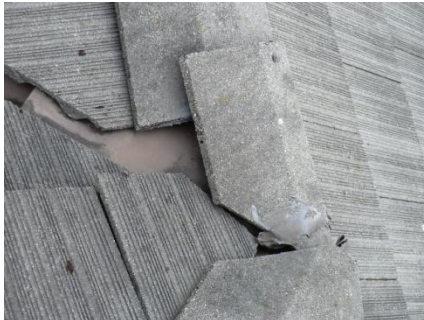
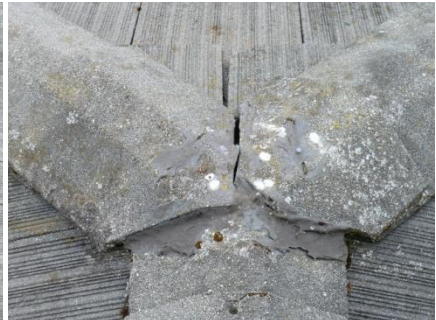
Roofing Observation

- ★ Many areas on roof need service. Although there is no visible active leaking during inspection, further evaluation is required or enquiry to the seller for more information.

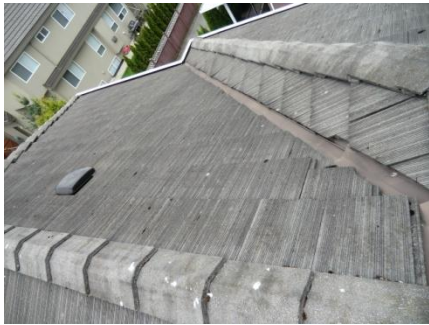
Flashings

- ★ The roof flashings are in acceptable condition.

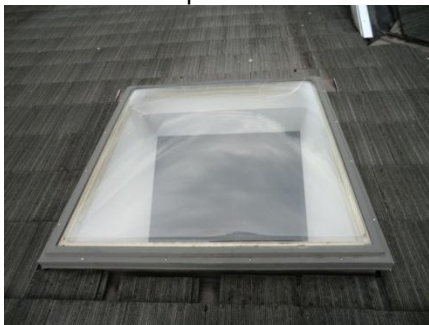
Skylights

- ★ Under acceptable condition.

The roof includes one or more skylights, which are notoriously problematic and a common point of leaks. There are different methods of installing them and, although opinions will vary, some methods are better than others. Therefore, it will be important to keep the area around them clean and to monitor them for evidence of leaks. 14

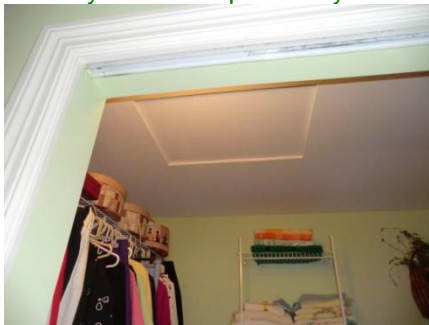
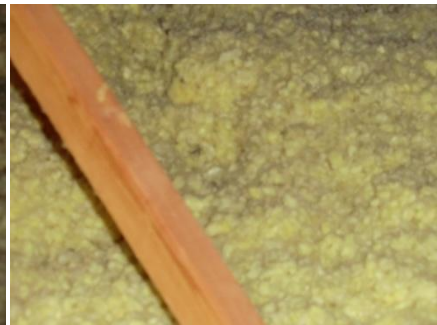
Method of Evaluation

- ★ We evaluated the attic by direct access.
- ★ There is sign of rodents' activity in attic before, not much but which could be a health hazard and should be evaluated by an exterminator. Rodents can compromise not only the attic and its various components, such as ducts and insulation, but can eventually compromise the living space as well. Consequently, we disclaim any further responsibility for evaluating the attic and its components.

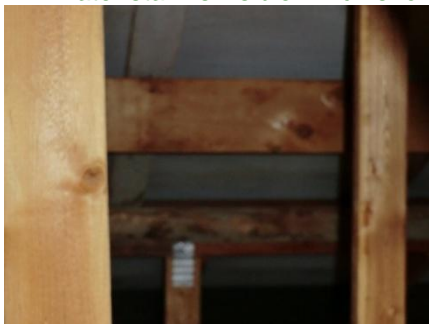
Framing

- ★ The roof framing consists of a factor- built truss system, comprised of components called chords, webs, and struts that are connected by wood or metal gussets nailed or glued in place. Each component of the truss is designed for a specific purpose, and cannot be removed or modified without compromising the integrity of the entire truss. The lowest component, which is called the chord and to which the ceiling is attached, can move by thermal expansion and contraction and cause creaking sounds, which are more pronounced structural significance, but can result in small cracks or divots in the drywall or plaster.
- ★ Water stain is visible which shows possible leakage before, which may need explanation from owner.

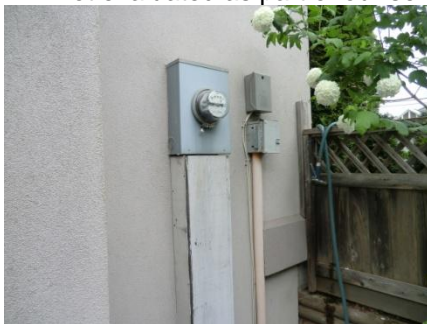
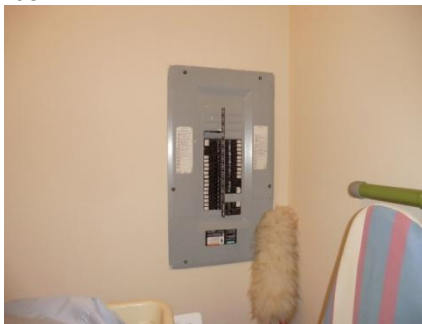
- ★ The main conductor lines are underground, or part of a lateral service entrance. This is characteristic of modern electrical services but, inasmuch as the service lines are underground and cannot be seen, they are not evaluated as part of our service.

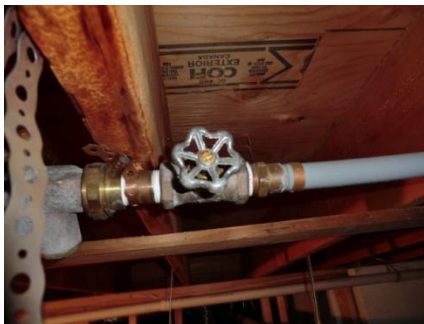
Water Main Shut-off Location

- * The main water shut-off valve is located at the crawl space.

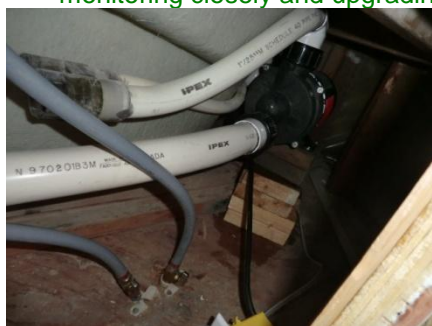
Copper and Plastic Water Pipes

- * The copper and plastic water pipes are in acceptable condition.
- * Poly-B pipe was found, which was normal in the building of this age. Poly-B caused leaking mostly for the plastic and Aluminum tubing. Although we did not found any live leaking during the inspection, we suggested monitoring closely and upgrading the piping if necessary.

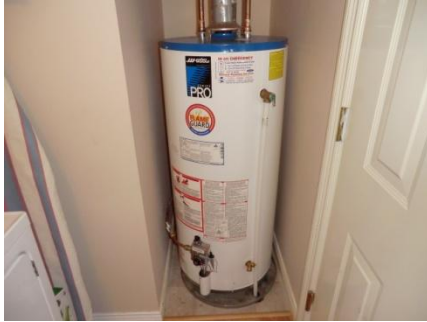
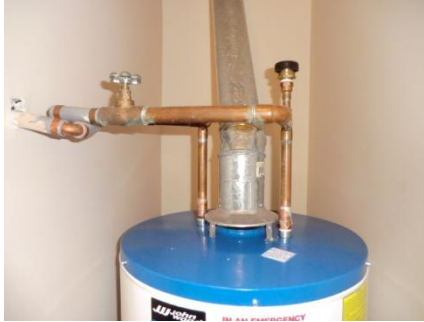
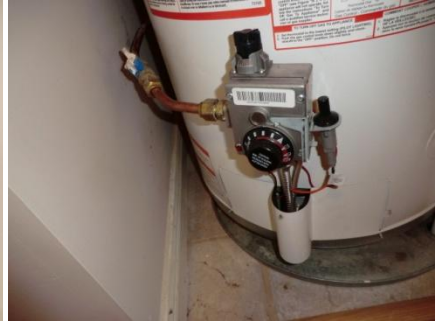
Common Observations

- * The water heater is functional and in good condition during inspection.

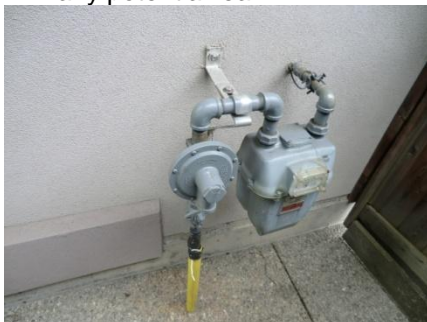
Gas Main Shut-Off Location

- * The gas main shut-off is located in the side of house. You should be aware that gas leaks are not uncommon, particularly underground ones, and that they can be difficult to detect without the use of sophisticated instruments, which is why natural gas is odorized in the manufacturing process. Therefore, we recommend that you request a recent gas bill from the sellers, so that you can establish a norm and thereby be alerted to any potential leak.

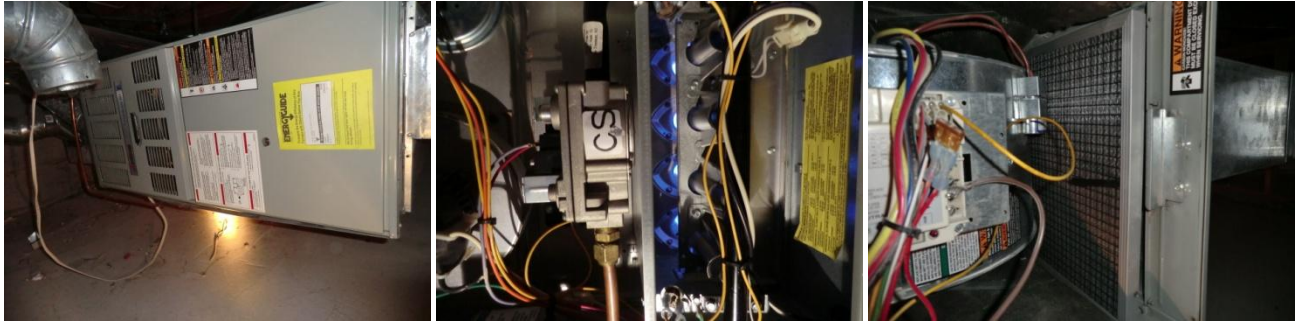
- * Heat is provided by a single 13 year-old furnace with an input capacity of 780,000 BTU per hour that is located in crawl.
- * The furnace is functional.

- * It is suggested that the furnace be serviced every year. Furnace units generally approximately have a 20 to 30 year life span. It is important to keep it serviced on a regular basis.

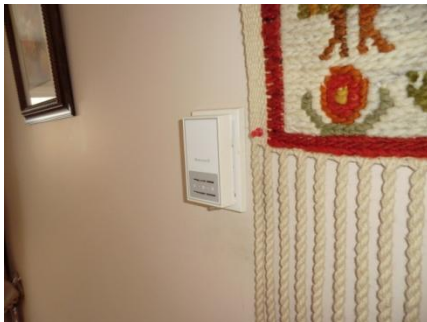
Thermostats

- * The thermostat is functional.

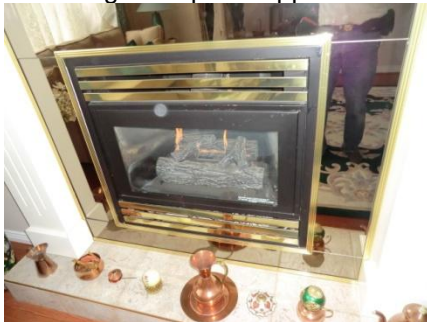
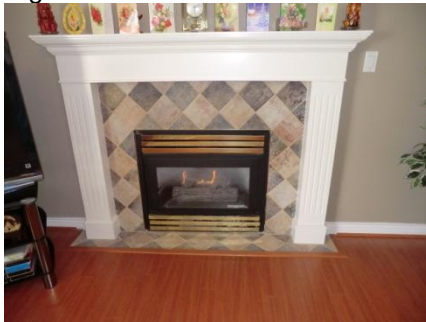
Fireplace

- ★ The gas fireplace appears to be in good condition when tested.

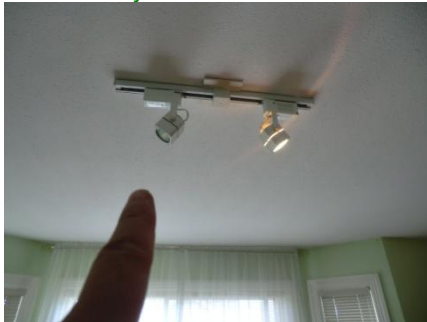
Interior lights

- ★ There are a few interior lights as shown not working during the inspection but supposed to be only the bulbs out or controlled by timer/sensor. Since this is common in a home, we won't specify them in each of following area unless it is a significant failure. We also suggest clients double checking the lights before moving in if this is your concern because they can fail anytime.

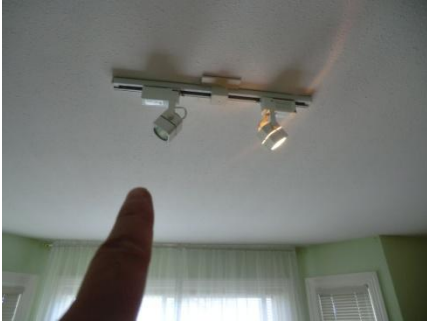
Lights

- * There is/are light(s) which does not respond and should be serviced.

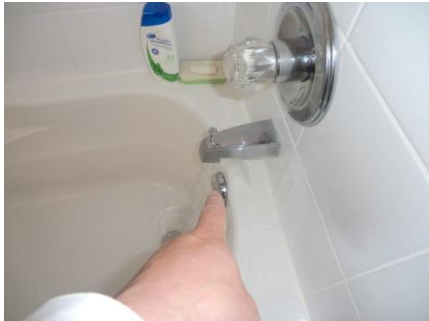
Tub Shower

- ★ The tub shower is functional.
- ★ There is some dripping at the faucet when turned on/off shower and should be serviced in upstairs 2nd bathroom.

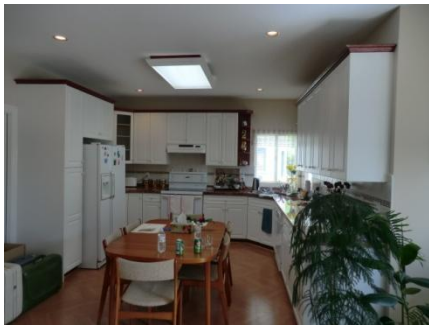
Kitchen

- ★ The brand name of dishwasher is "Concept", which is dripping when testing and should be serviced or replaced.

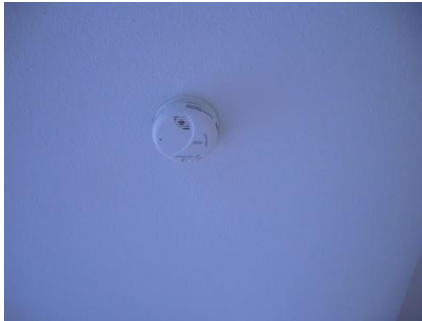
Upper Floor Hallway

- ★ We have evaluated the hallway, and found it to be in acceptable condition.

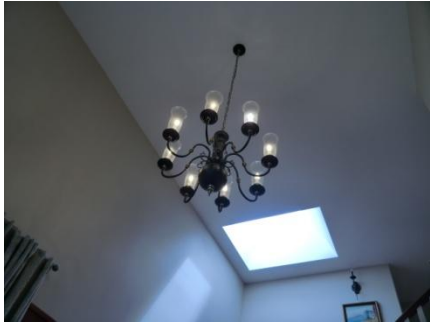
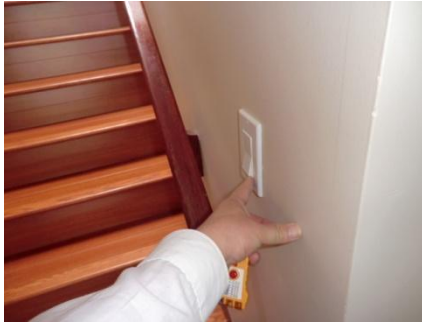
Lights

- ★ The lights are functional.
- ★ The 2-way or 3-way main entry light switches are not working properly, which needs service

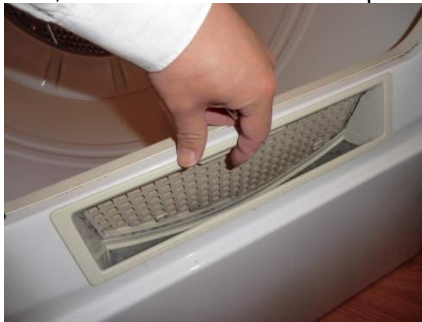
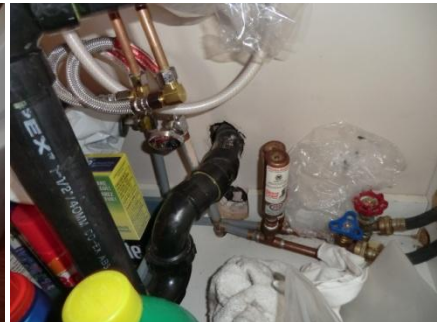
Laundry Room

- ★ We have evaluated the laundry room, and found it to be in acceptable condition.

- ★ The dryer is functional.
- ★ The brand name of dryer is "GE"

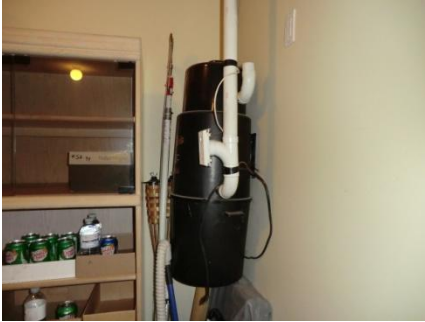
Central Vacuum

- ★ The vacuum appears to be in good condition when tested.

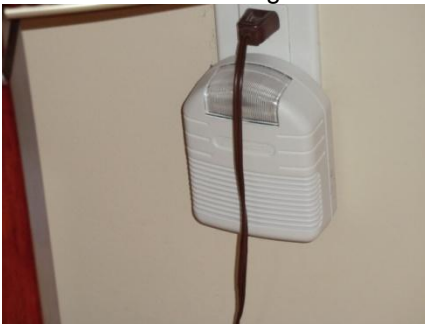
Door Bell

- ★ The door bell is in good condition when tested.
