COMFORT HOME REVIEW

CONFIDENTIAL INSPECTION REPORT

INSPECTION ADDRESS

INSPECTION DATE

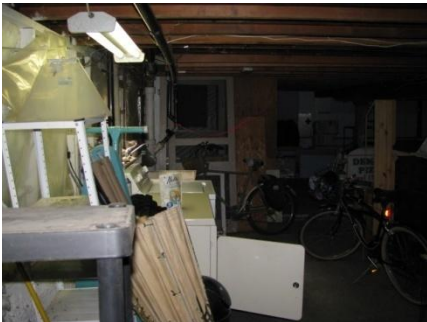
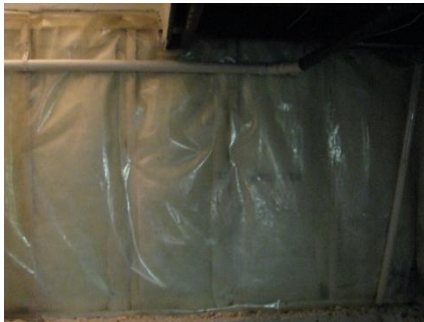
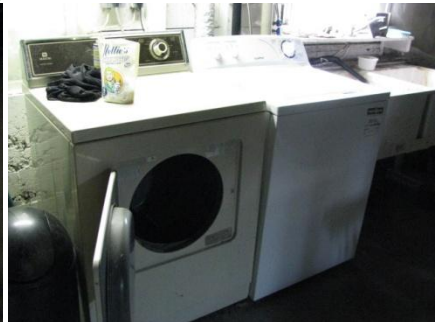
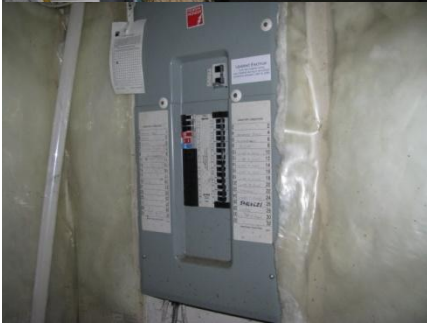
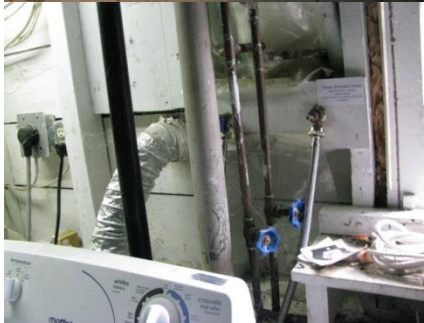
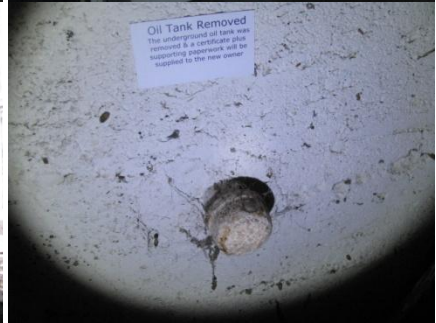
- ★ The basement was elevated but not tall enough to finish for living space. It seemed structurally sound but remodel and renovation permit should be requested to make sure safety. So do the property electrical, plumbing and drainage, also the buried oil tank removal clearance, which had been updated. (地下室是后期提升的, 但是高度不足以装修成生活空间, 尽管看起来结构安全, 但是应该索取改造、翻新许可, 包括有过翻新的电、水管、墙基排水的翻新许可, 另外还有地下油缸的移除证明)

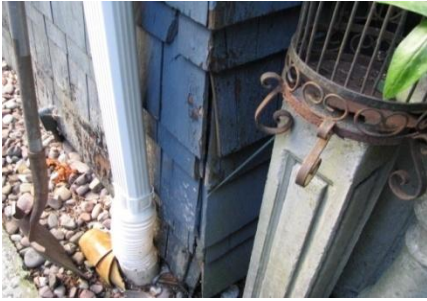
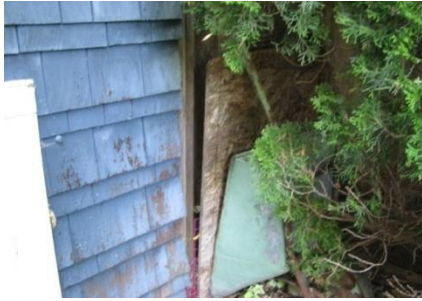
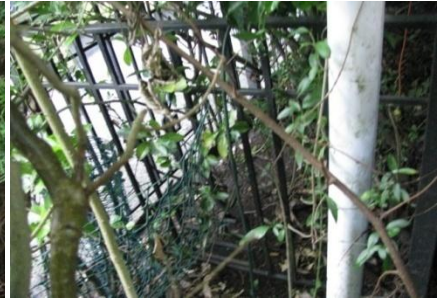
House Wall Finish Observations

- ★ The house exterior wall finish is under acceptable condition but spotty and regular maintenance services are required. The east side of house is not accessible, therefore no observation and inspection are in the area. (外墙状况正常, 个别位置需要正常维修, 物业东侧无法进入, 因此没有观察和评价)

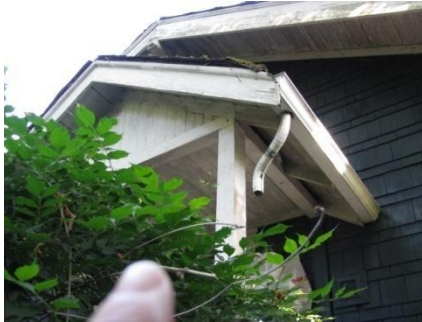
Downspout (屋顶排水)

- ★ The disconnected downspouts should be serviced.(断开的落水水管需要修缮)

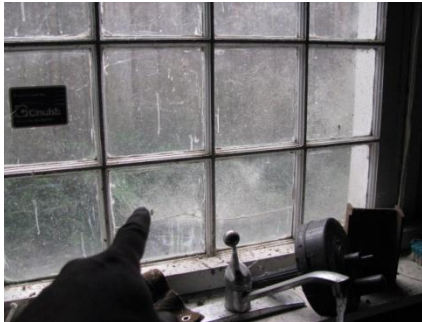
Windows (窗户)

- ★ Most windows are single glazed. Some window panes have cracks damage.(大部分窗子为单层玻璃，个别窗玻璃有裂缝)

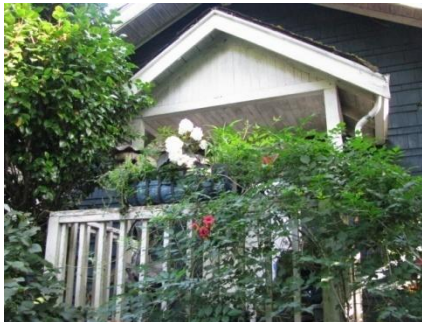
Landscaping (庭院)

- ★ Vegetation is encroaching on the structure, and should be kept a minimum of twelve inches away for the general welfare of the walls and foundation. Also the garden and trees on the property should be trimmed. (植物生长过于靠近建筑，建议至少12" 间隔，庭院植物、树木应该剪枝)

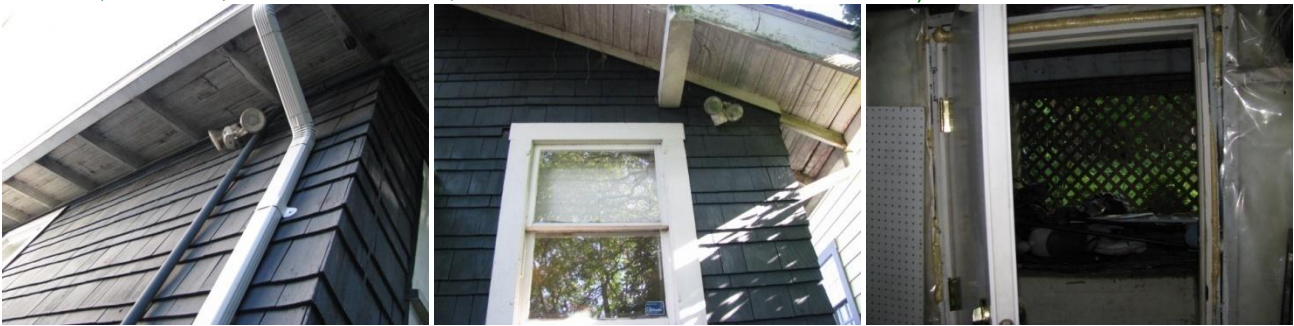
Lights (灯)

- ★ A few exterior light fixtures are not working, and should be serviced. They may be controlled by timer or sensors. Please ask seller for more information. The basement walkout light installation is required. (个别灯不工作, 需要维修; 或者是传感器控制, 需向屋主了解, 地下室室外门加装照明)

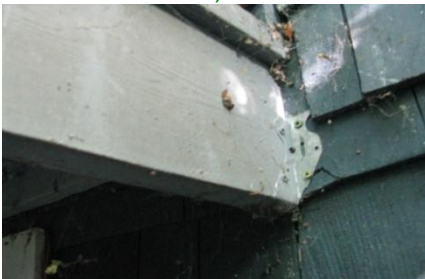
Porches (门廊)

- ★ Components of **Porches** are in acceptable condition but the back porch joist hanger is undersized, which contractor service and secure is suggested. (前后门廊状况正常, 但是后门廊的木梁墙上紧固件偏小, 建议专业维护、加固)

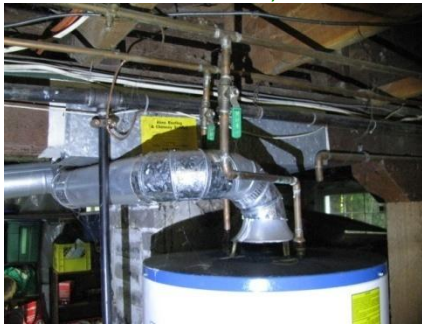
Common Observations (观察)

- ★ The water heater is functional but 12 yrs old is close to life expectancy. The probability of failure is high. (工作正常, 但是已经12年接近使用寿命, 损坏的可能性比较大)

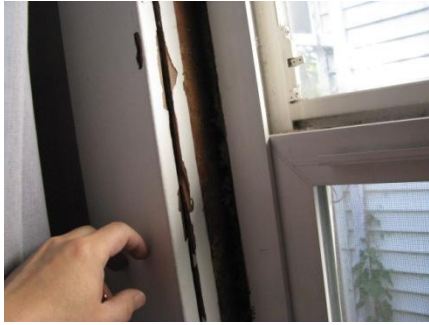
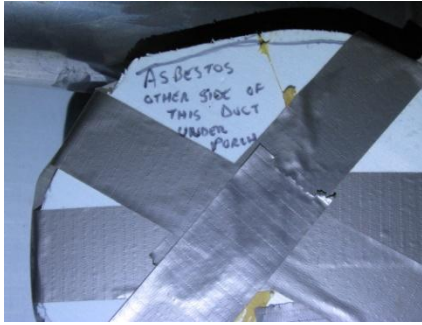
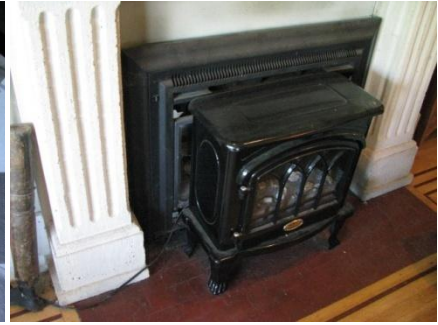
- ★ The interior appears old property like single glazed windows, old plumbing fixtures and added bath exhaust fan no outside vent in place, also tenant occupied lack of maintenance condition such as worn flooring, cracked ceiling/wall, loose doors and unfinished bedroom window casing. Some services are required right away ex. dripping bath tub drain, smoke detector update and basement stairs handrail installation for safety, also loose kitchen sink tap. The interior has the moldy smell which may result from the pets and none operable windows in living and dining. Asbestos is not avoidable in old timer. Therefore, professional cleaning, evaluation and renovation is suggested.) (室内有老旧物业特征如单层玻璃窗，老式水龙头浴缸及卫生间排风扇无室外出口，加之租客占用缺乏维护，状态欠佳如磨损的地面材料、开裂的天花墙壁、松脱的门和未完工的卧室窗口；有些需要立即修缮如浴缸下水漏，加装楼梯扶手、更新烟感，及修缮厨房水龙头。室内有霉味可能与客厅餐厅窗子打不开加之饲养宠物有关，老物业石棉材料不可避免，建议专业清洁、评估或翻新)

- ★ It looks like the gas fireplace insert has broken down. (看似后加燃气壁炉已经损坏，前面加了电的)

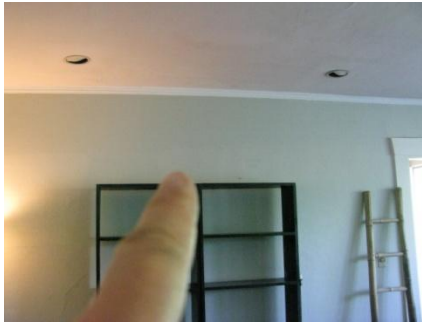
- ★ There are a few interior lights as shown not working during the inspection but supposed to be only the bulbs out or controlled by timer/sensor. Since this is common in a home, we won't specify them in each of following area unless it is a significant failure. We also suggest clients double checking the lights before moving in if this is your concern because they can fail anytime. (室内有一些灯不工作，应该只是更换灯泡的问题或者被感应器控制，因为该情况在家居中常见，除非是特别重要的损坏我们不会在下面室内的各个部分提及。如果认为很重要，我们还建议客人在搬入前再次检查所有的灯具照明，因为其可能会在任何时间损坏)

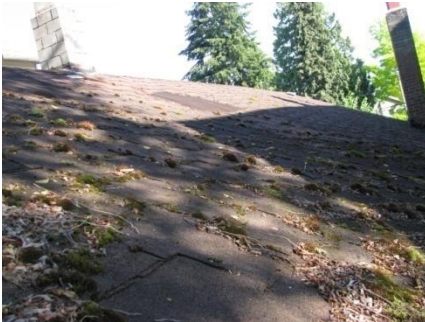
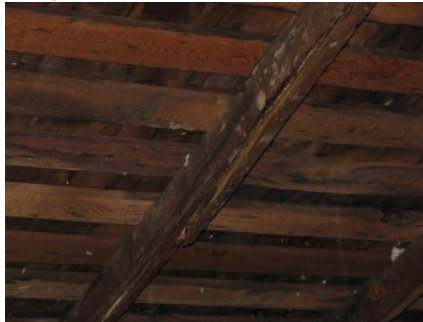
Identification of Roof Structure (屋顶结构)

- ★ The roof structure is damaged, which dish roof is visible from roof top; cracked and bend rafters are noticed at attic. The contractor evaluation and repair is required. It looks like an impact damage, which owner enquiry is suggested. (屋顶结构受损, 从屋顶上看有局部凹陷, 阁楼观察有木梁开裂和弯曲, 需要专业评估并维修。应该寻问屋主是否有过重物击打所致)

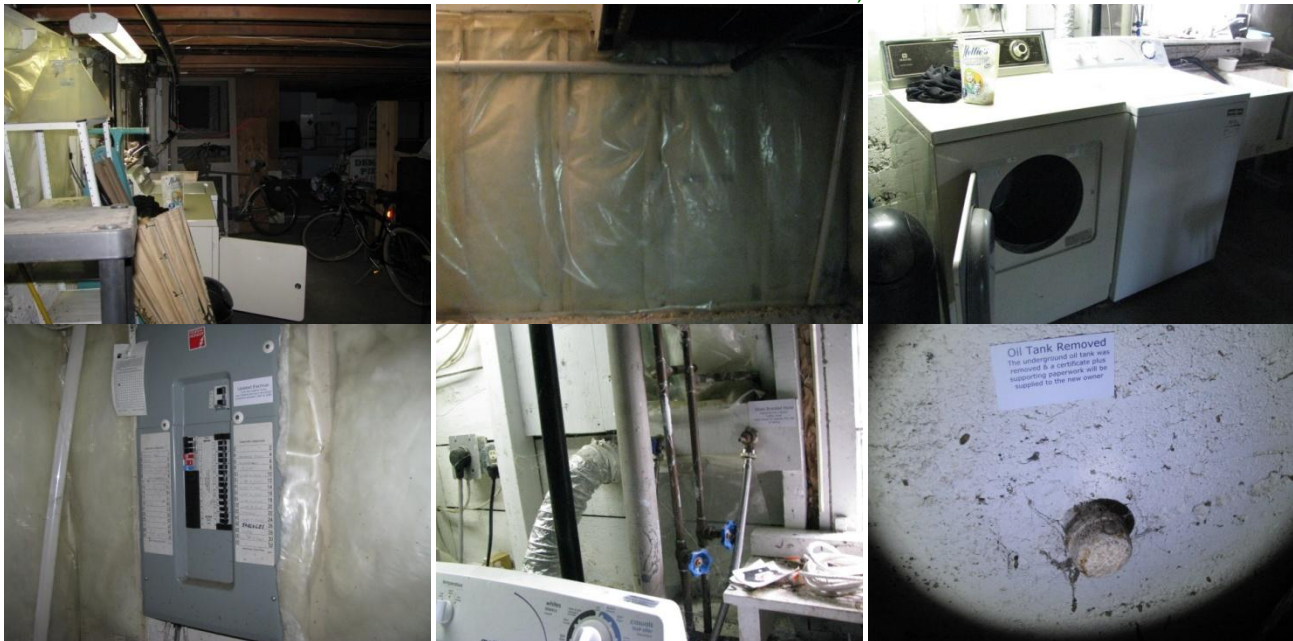
- ★ The basement was elevated but not tall enough to finish for living space. It seemed structurally sound but remodel and renovation permit should be requested to make sure safety. So do the property electrical, plumbing and drainage, also the buried oil tank removal clearance, which have been updated. (地下室是后期提升的, 但是高度不足以装修成生活空间, 尽管看起来结构安全, 但是应该索取改造、翻新许可, 包括有过翻新的电、水管、墙基排水的翻新许可, 另外还有地下油缸的移除证明)

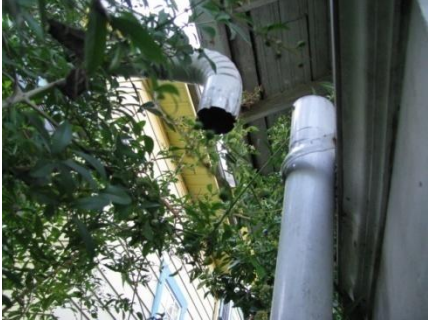
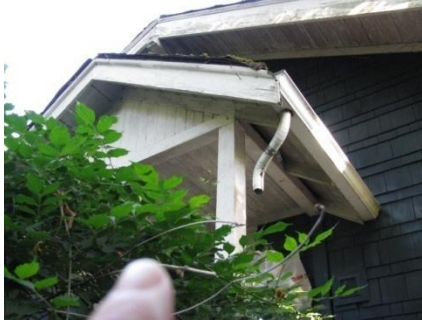
Downspout (屋顶排水)

- ★ The disconnected downspouts should be serviced.(断开的落水水管需要修缮)

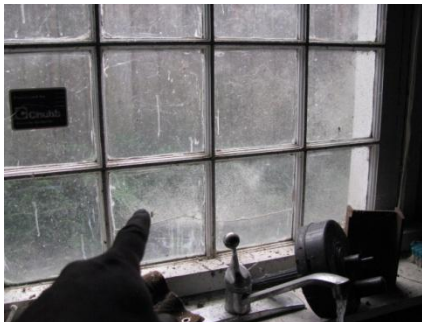
Windows (窗户)

- ★ The windows are in acceptable condition. However, in accordance with industry standards, we do not test every window in the house, and particularly if the house is furnished. We do test every unobstructed window in every bedroom to ensure that at least one facilitates an emergency exit. (窗户状况正常, 我们检查卧室里没障碍物的窗, 以确保有紧急出口)
- ★ Most windows are single glazed. Some window panes have cracks damage.(大部分窗子为单层玻璃, 个别窗玻璃有裂缝)

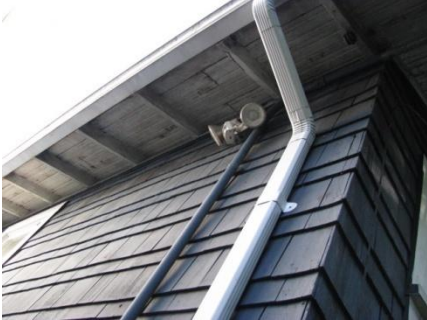
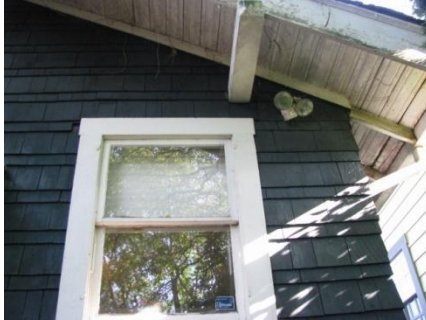
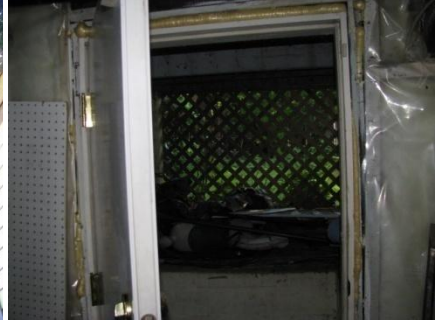
Lights (灯)

- * A few exterior light fixtures are not working, and should be serviced. They may be controlled by timer or sensors. Please ask seller for more information. The basement walkout light installation is required. (个别灯不工作, 需要维修; 或者是传感器控制, 需向屋主了解, 地下室室外门加装照明)

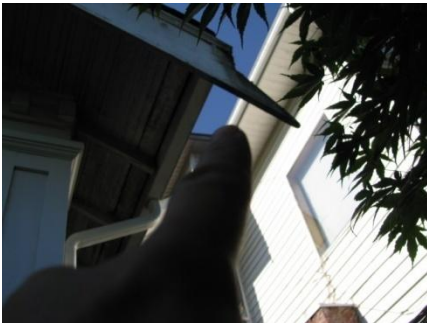
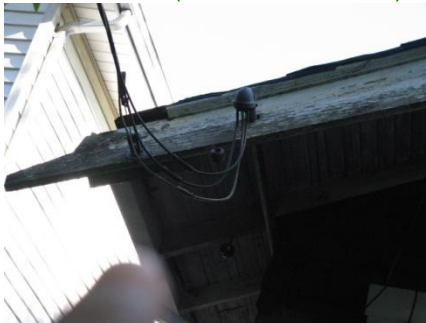
Fascia & Trim (檐板)

- * The fascia board and trim, should be serviced. (檐板个别需要维护)

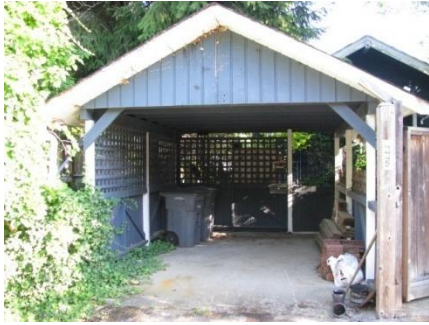
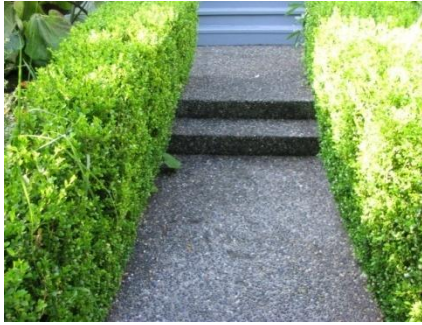
Drive way & walks (车道和走道)

- * Drive way is acceptable. (车道状况正常)
- * Walk way is acceptable. (走道状况正常)

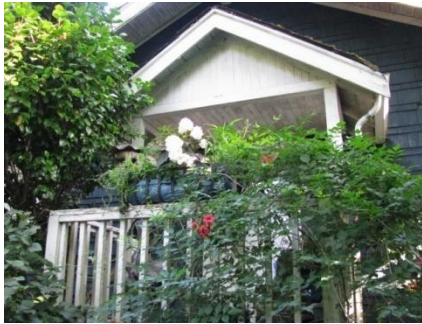
Landscaping (庭院)

- ★ Vegetation is encroaching on the structure, and should be kept a minimum of twelve inches away for the general welfare of the walls and foundation. Also the garden and trees on the property should be trimmed. (植物生长过于靠近建筑, 建议至少12" 间隔, 庭院植物、树木应该剪枝)

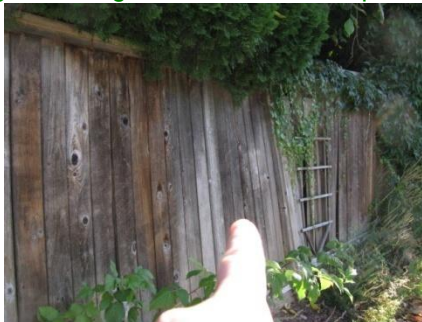
Fences & Gates (围墙及门)

- ★ Sections of the fence are leaning or damaged and should be repaired or replaced. (有破损, 建议维修更换)

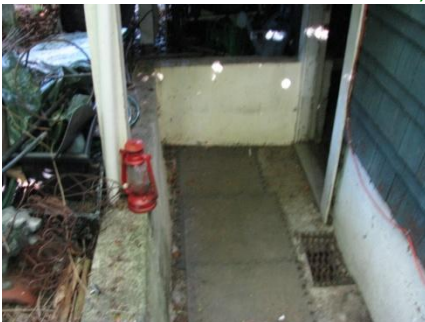
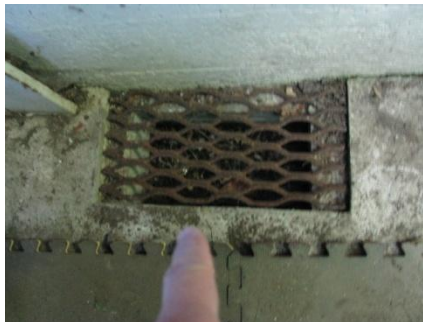
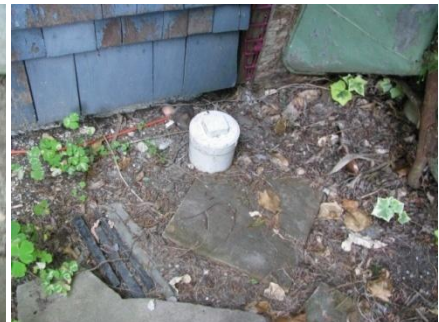
Area Drains (局部下排水)

- ★ The basement walkout drain has not been serviced for a long time. Therefore the roter cleaning and inspection service is required including the drain tiles. (地下室门前的下水口长期没有清理, 需要排水专业人员清理、检查, 包括对墙基排水管)

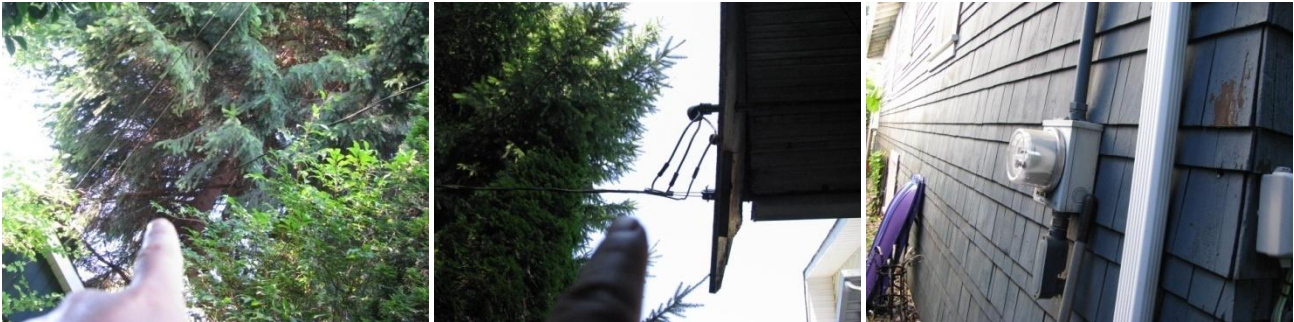
Service Entrance (进线)

- ★ The utility company's overhead conductor lines are being stressed by tree limbs that should be trimmed away. (悬挂进线受压于树枝, 剪枝)

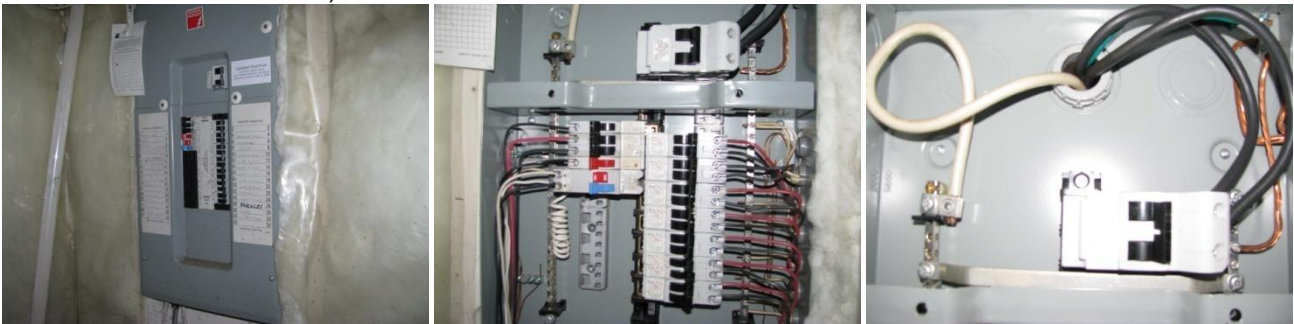
Panel Size, Location & Observation (供电容量/位置)

- ★ The residence is served by a 100 amp, 110/220 volt panel, located inside the basement. (总容量100A, 110/220V电盘在地下室)

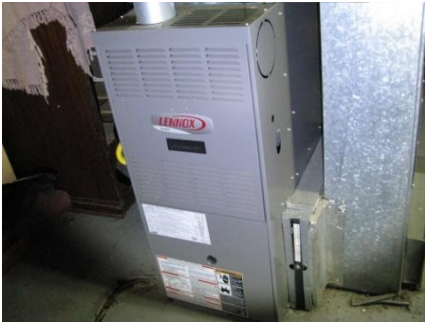
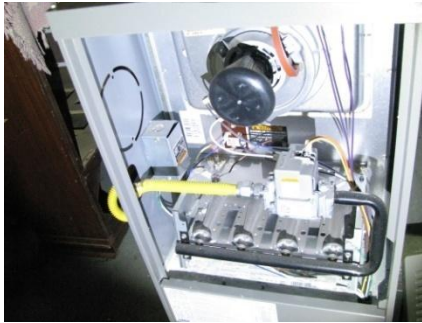
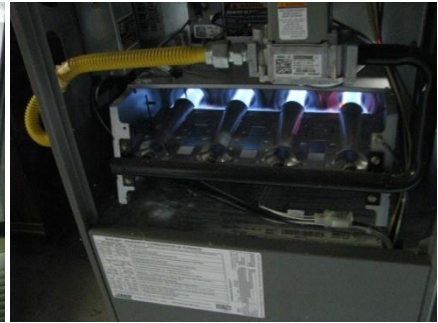
Age & Location (年限位置)

- ★ Heat is provided by a single 12 year-old furnace with an input capacity of 88,000 BTU per hour that is located in basement. (工作12年88,000 BTU位于地下室贮藏间)
- ★ The furnace is functional. (工作正常)

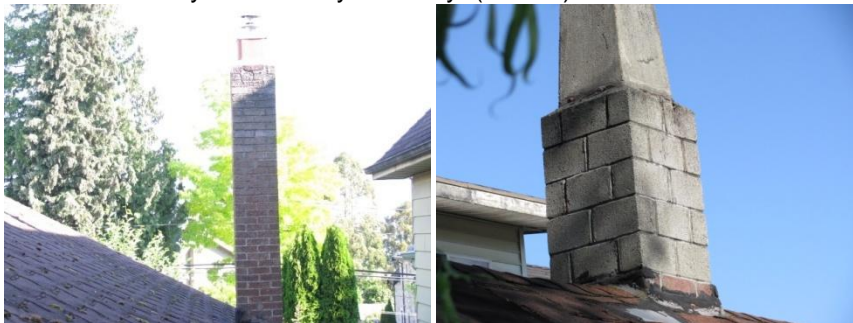
Chimney Construction (烟囱构造)

- ★ The condition of the chimney is acceptable. (状况正常)
- ★ The chimney was built by masonry. (砖结构)

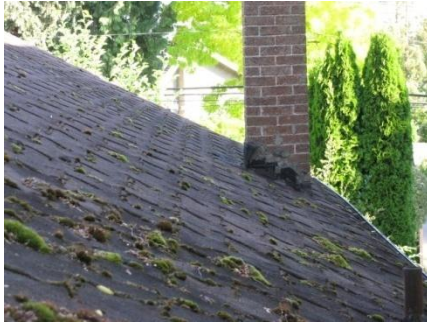
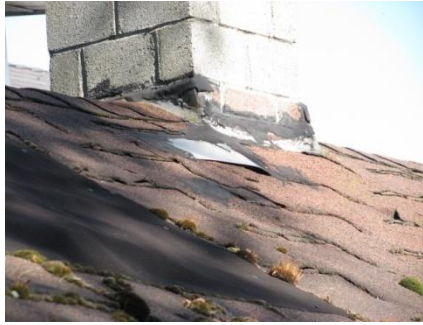
Chimney Flashings (防水板)

- ★ The condition of chimney flashing is acceptable. (状况正常)

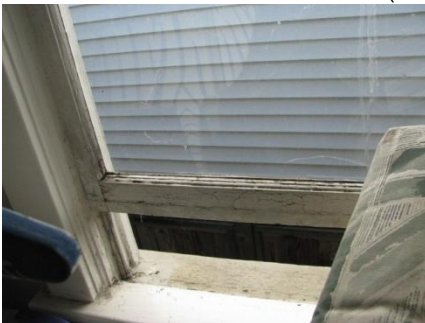
Windows (窗户)

- ★ The windows are functional. (正常)

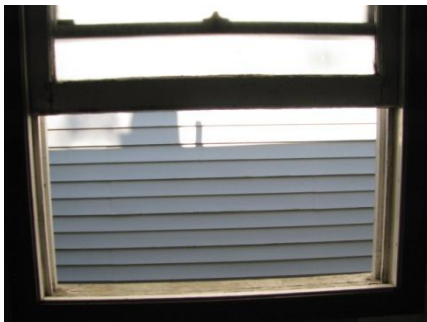
Windows (窗户)

- ★ The windows that were unobstructed were checked, and found to be functional. (正常)

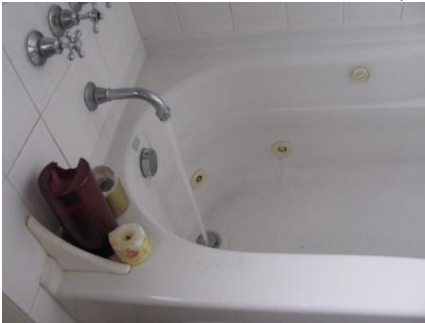
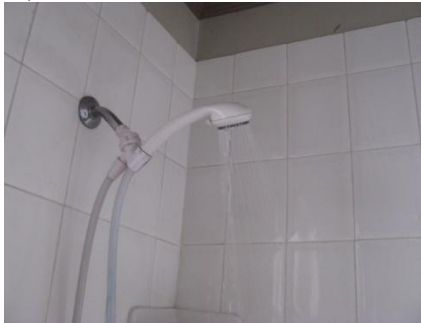
Tub Shower (浴盆)

- ★ The tub shower is functional. (正常)

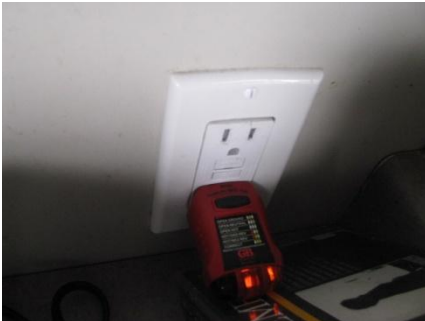
Outlets (插座)

- ★ The outlets are functional and include ground-fault protection. (正常, 有漏电保护)

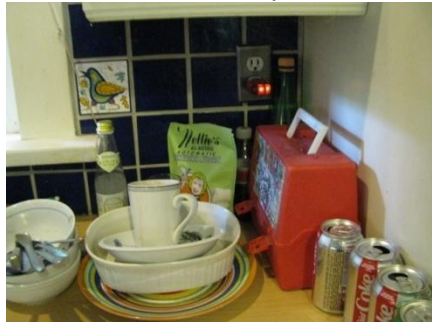
Sink Countertop (水盆台面)

- * The sink countertop is functional. (正常)

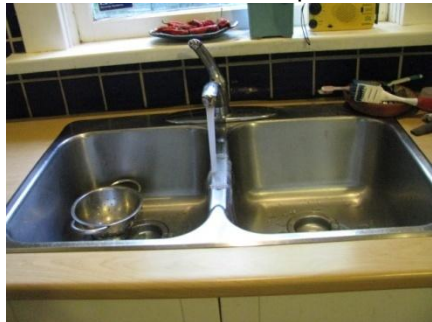
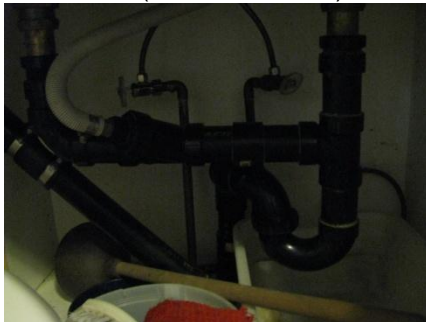
Sink Faucet Valves & Connectors Trap & Drain (水嘴, 回水弯及下水)

- * The sink and its components are functional. (水盆及组件正常)

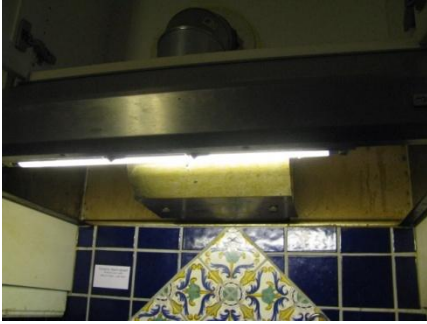
Exhaust Fan or Downdraft (抽油烟机)

- ★ The exhaust fan or downdraft is functional. (工作正常)

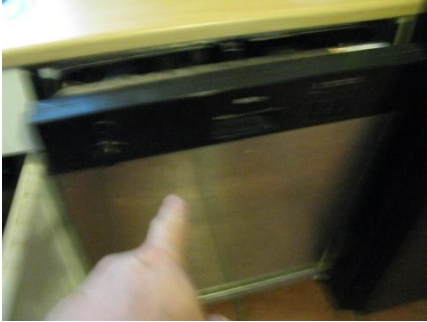
Dishwasher (洗碗机)

- ★ The dishwasher is functional at inspection. (检查时工作正常)

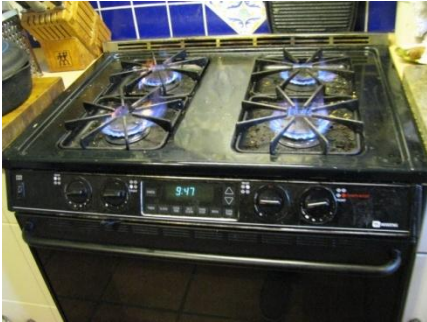
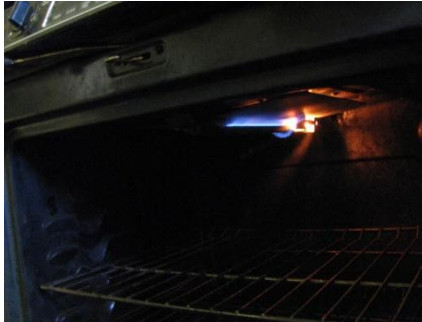
Gas Range (整体燃气炉)

- ★ The gas range is functional, but was neither calibrated nor tested for its performance. (正常但我们不进行校准)

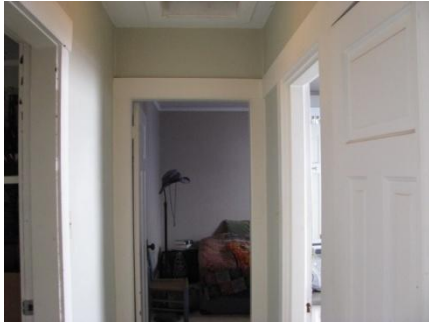
Floor Hallway (过厅)

- ★ We have evaluated the hallway, and found it to be in acceptable condition. (条件正常)
